**International Conference
Bibliothèque nationale de France
5-6 March 2009**

**WIND RESISTANCE STRATEGIES
FOR CULTURAL HERITAGE
BUILDINGS IN THE AFTERMATH
OF HURRICANE KATRINA**

Elizabeth C. English, PhD
Associate Professor
University of Waterloo School of Architecture

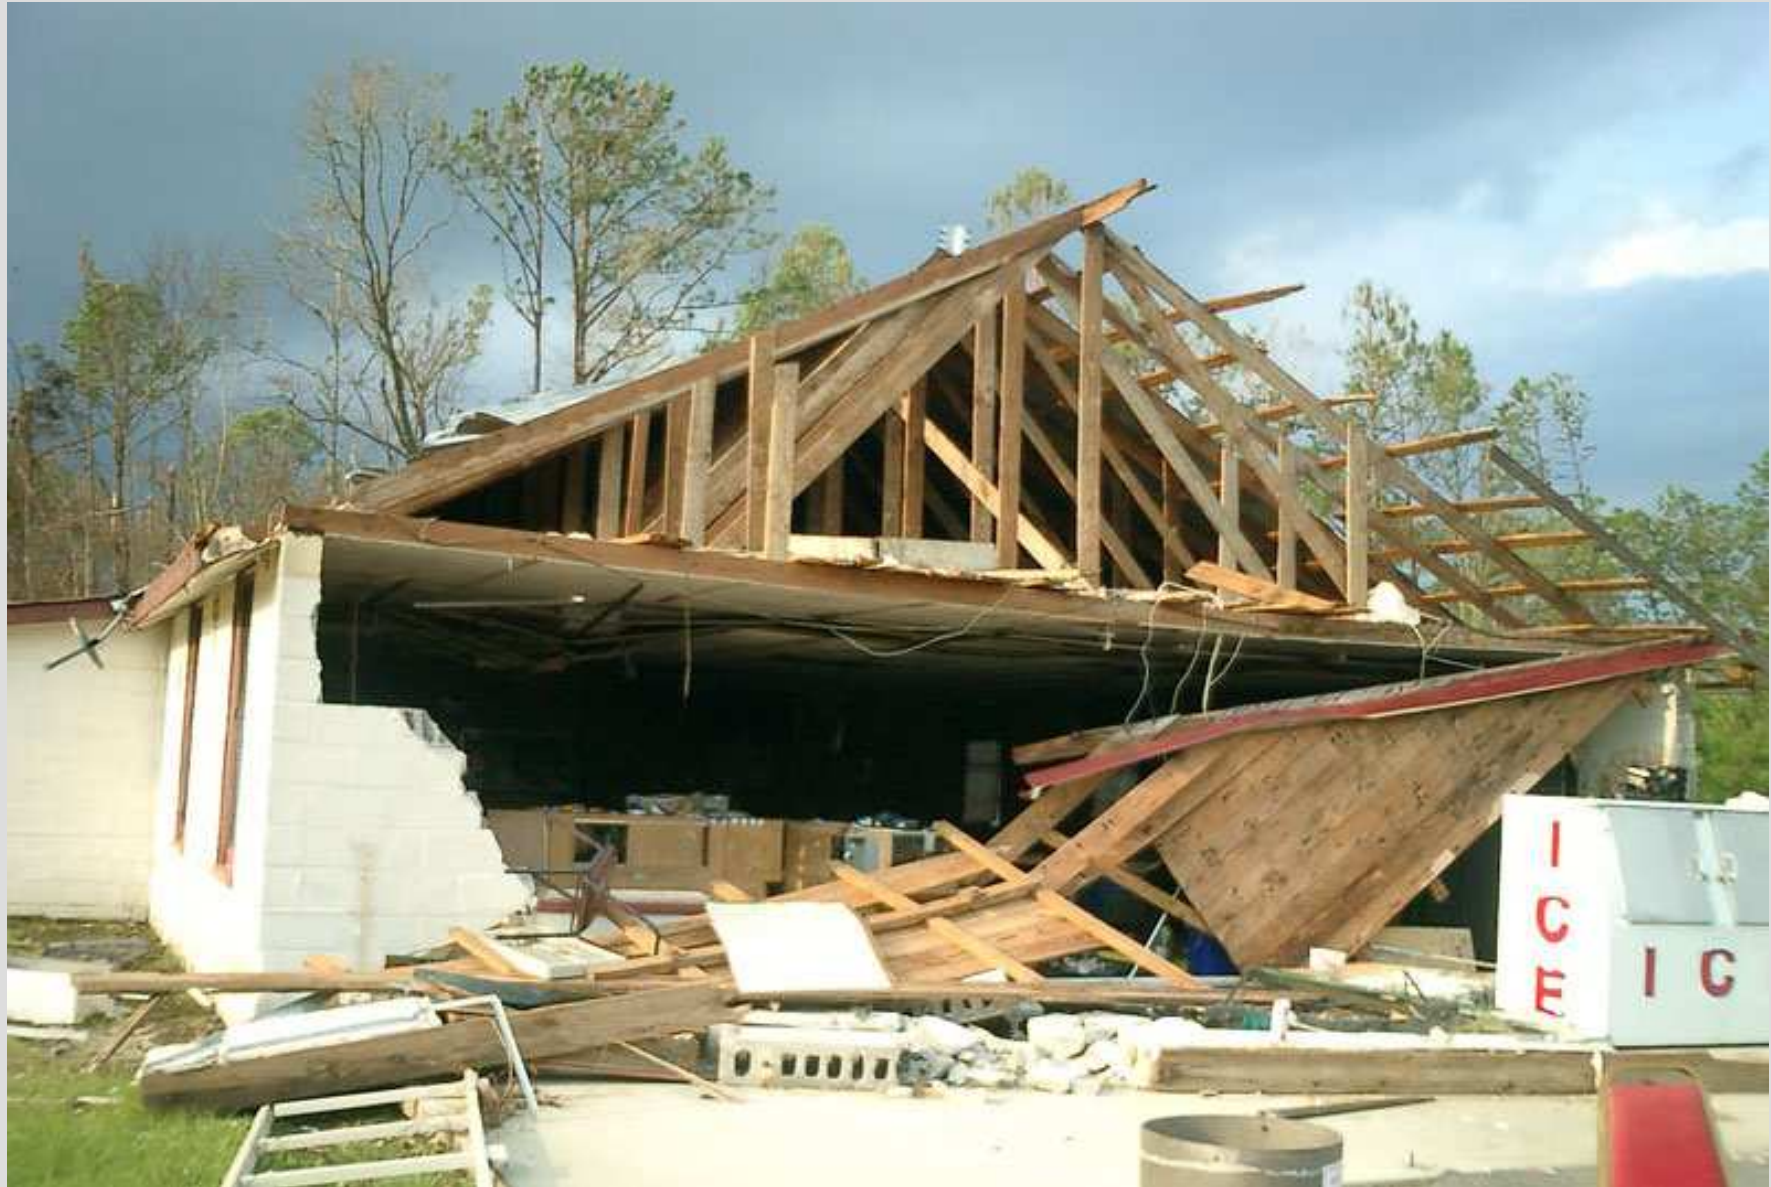
Wind damage to shop structure near Long Beach MS

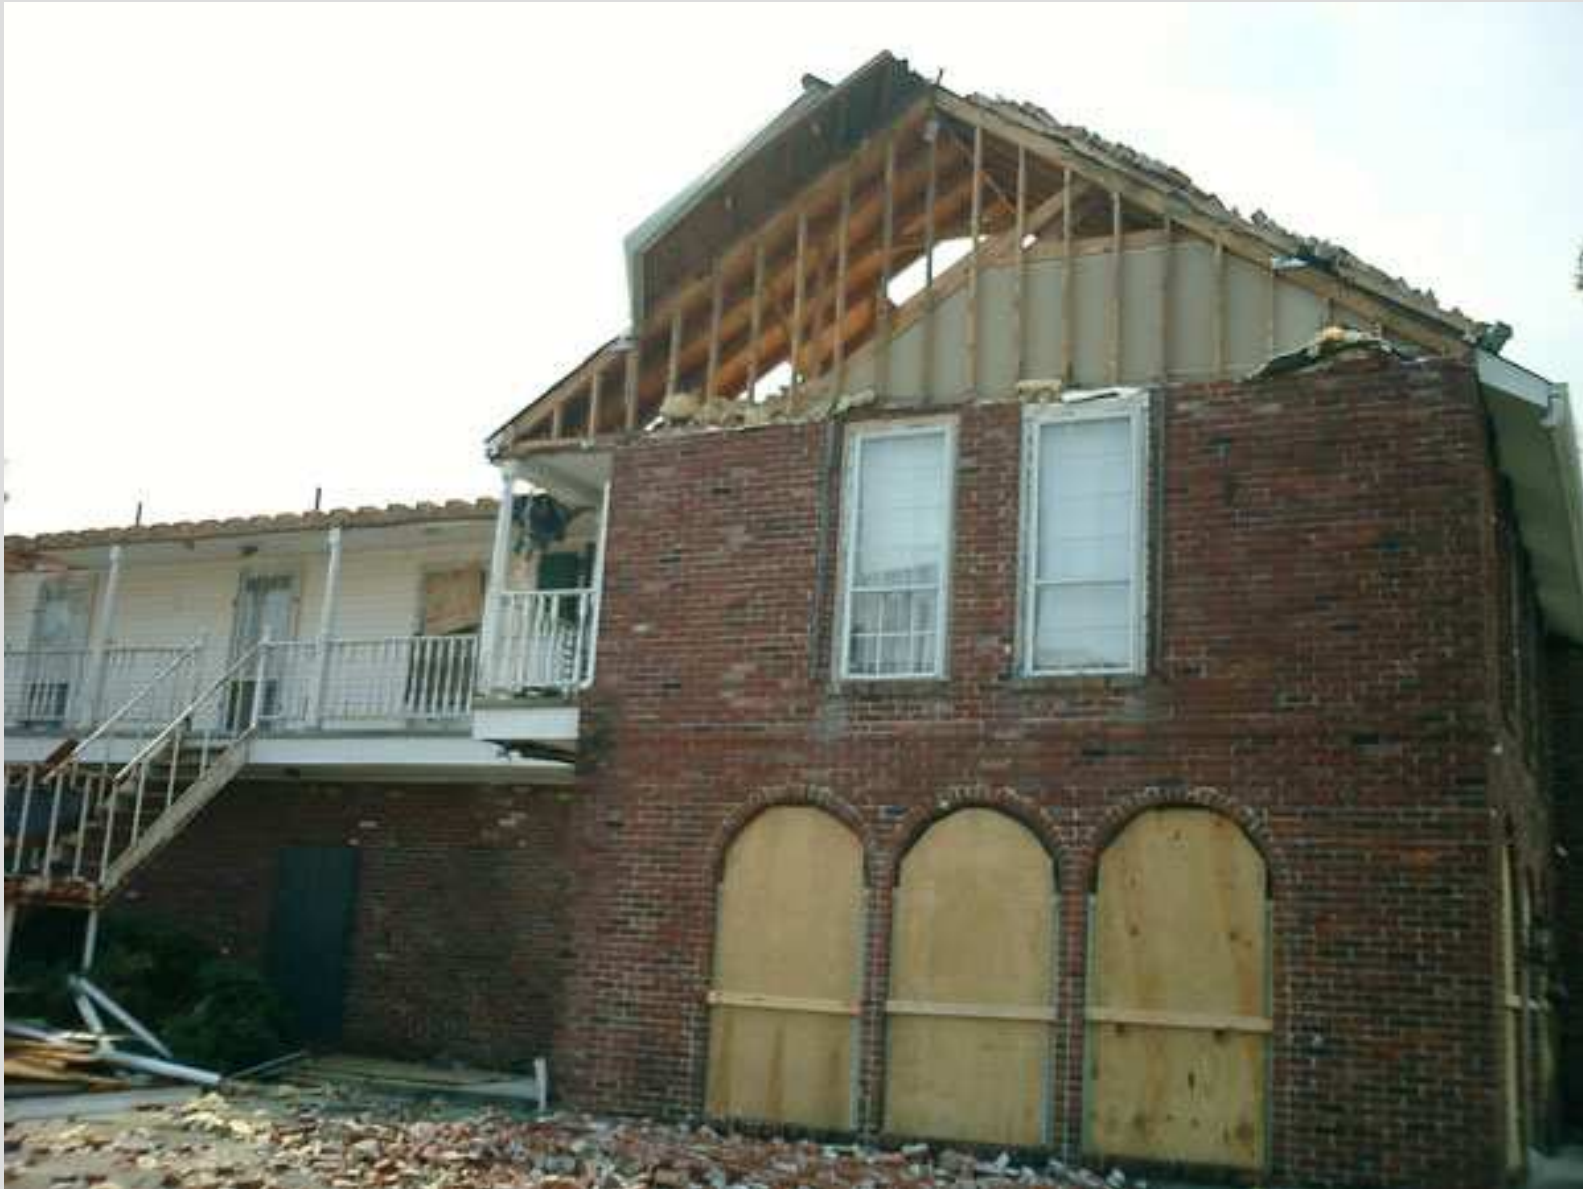
Wind-damaged apartments near West Jefferson Hospital – classic gable end failure

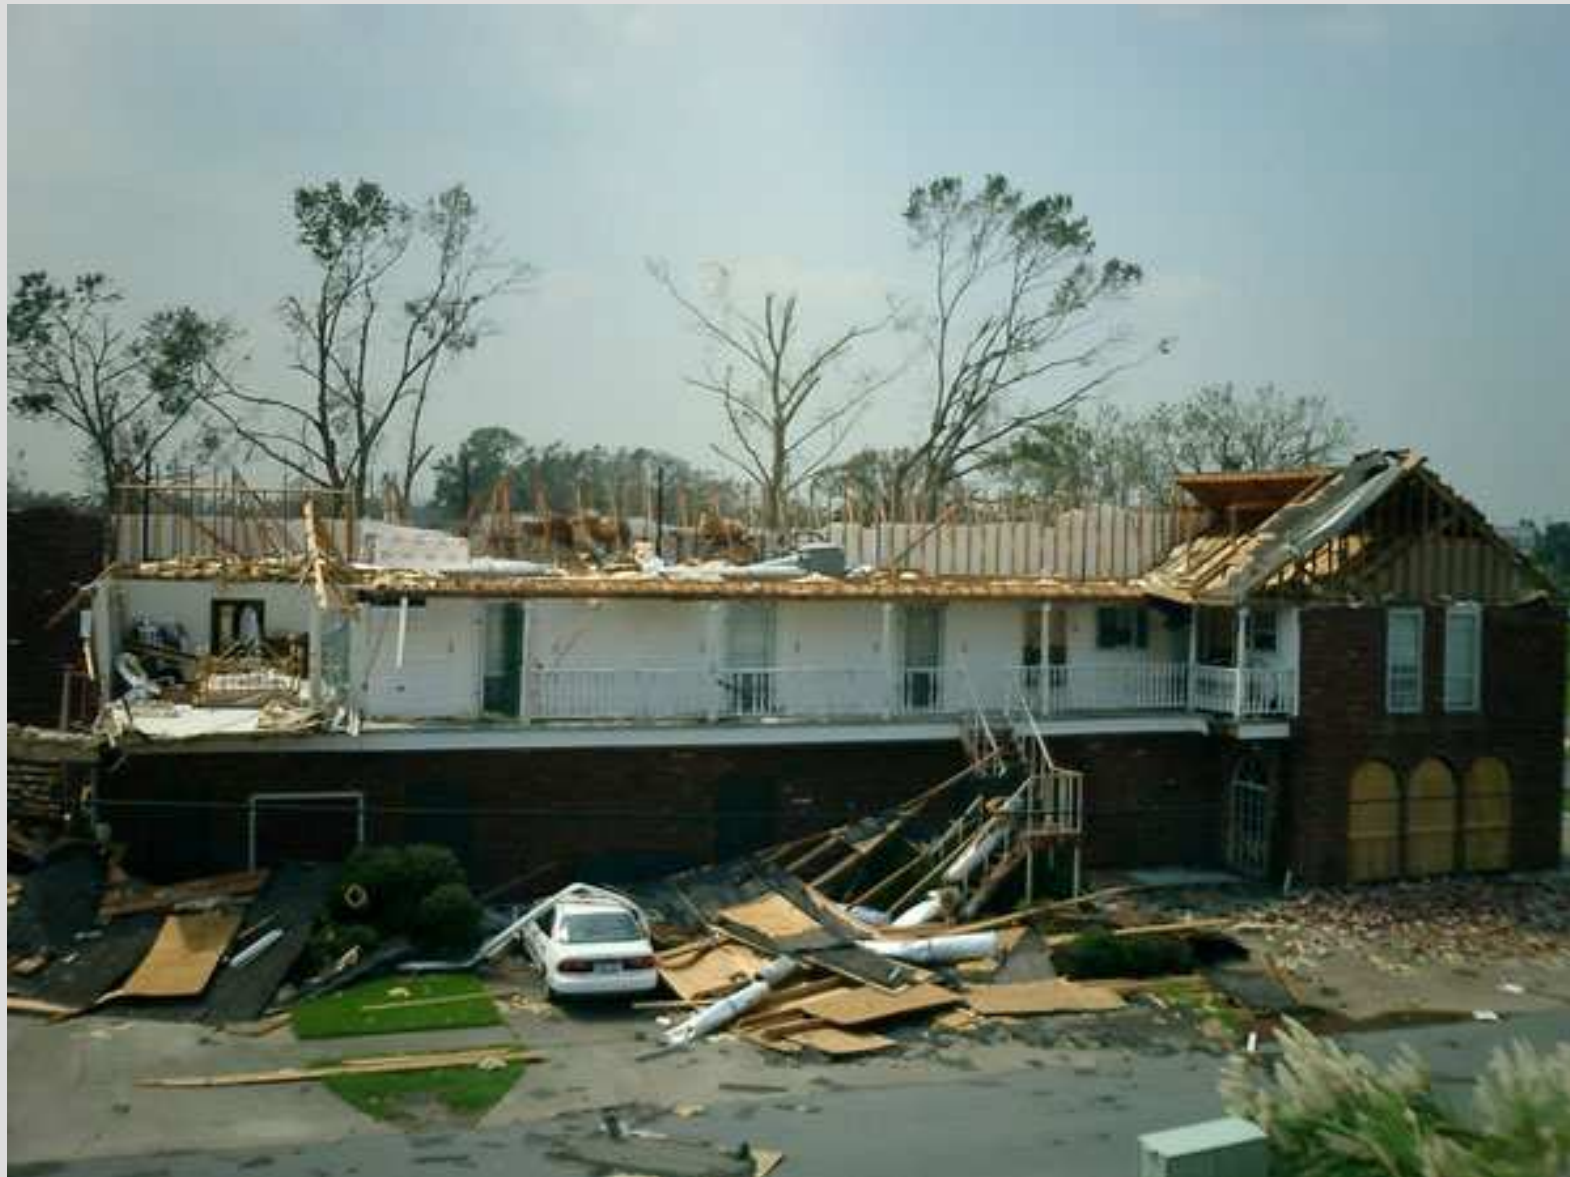
Gable end failure causes loss of roof due to increased internal pressure

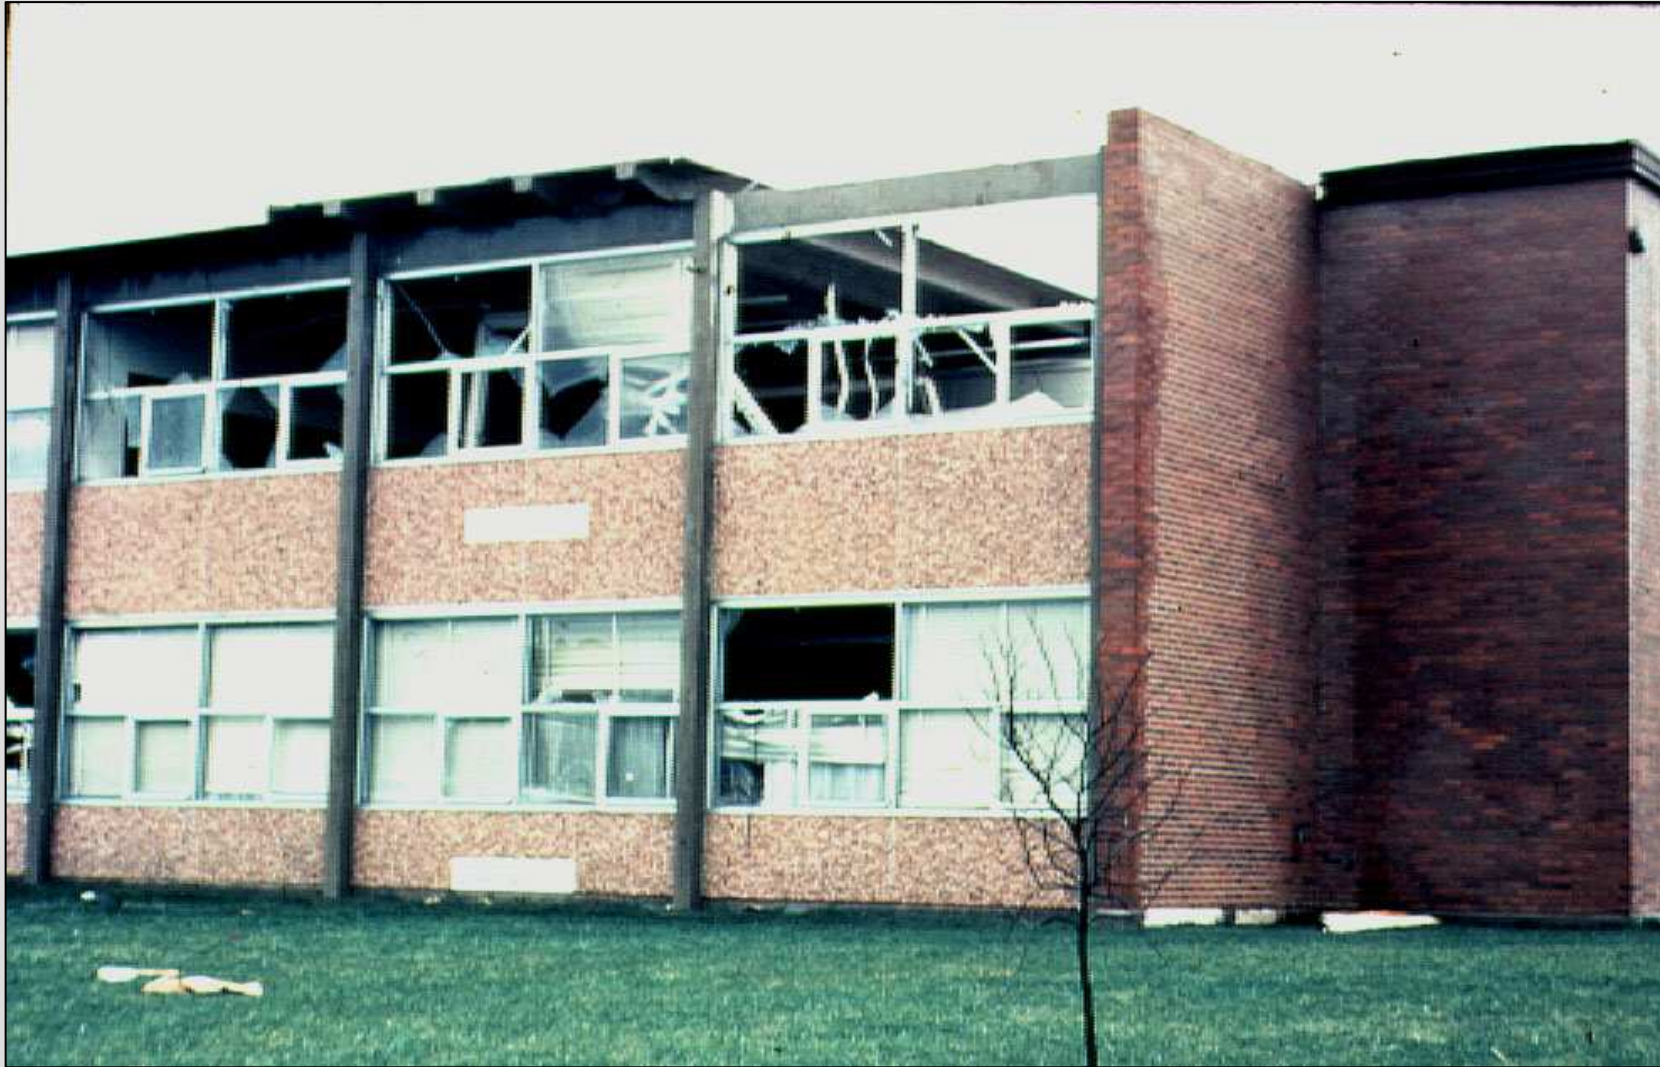
Wind-borne debris causes damage to windows, followed by failure of roof

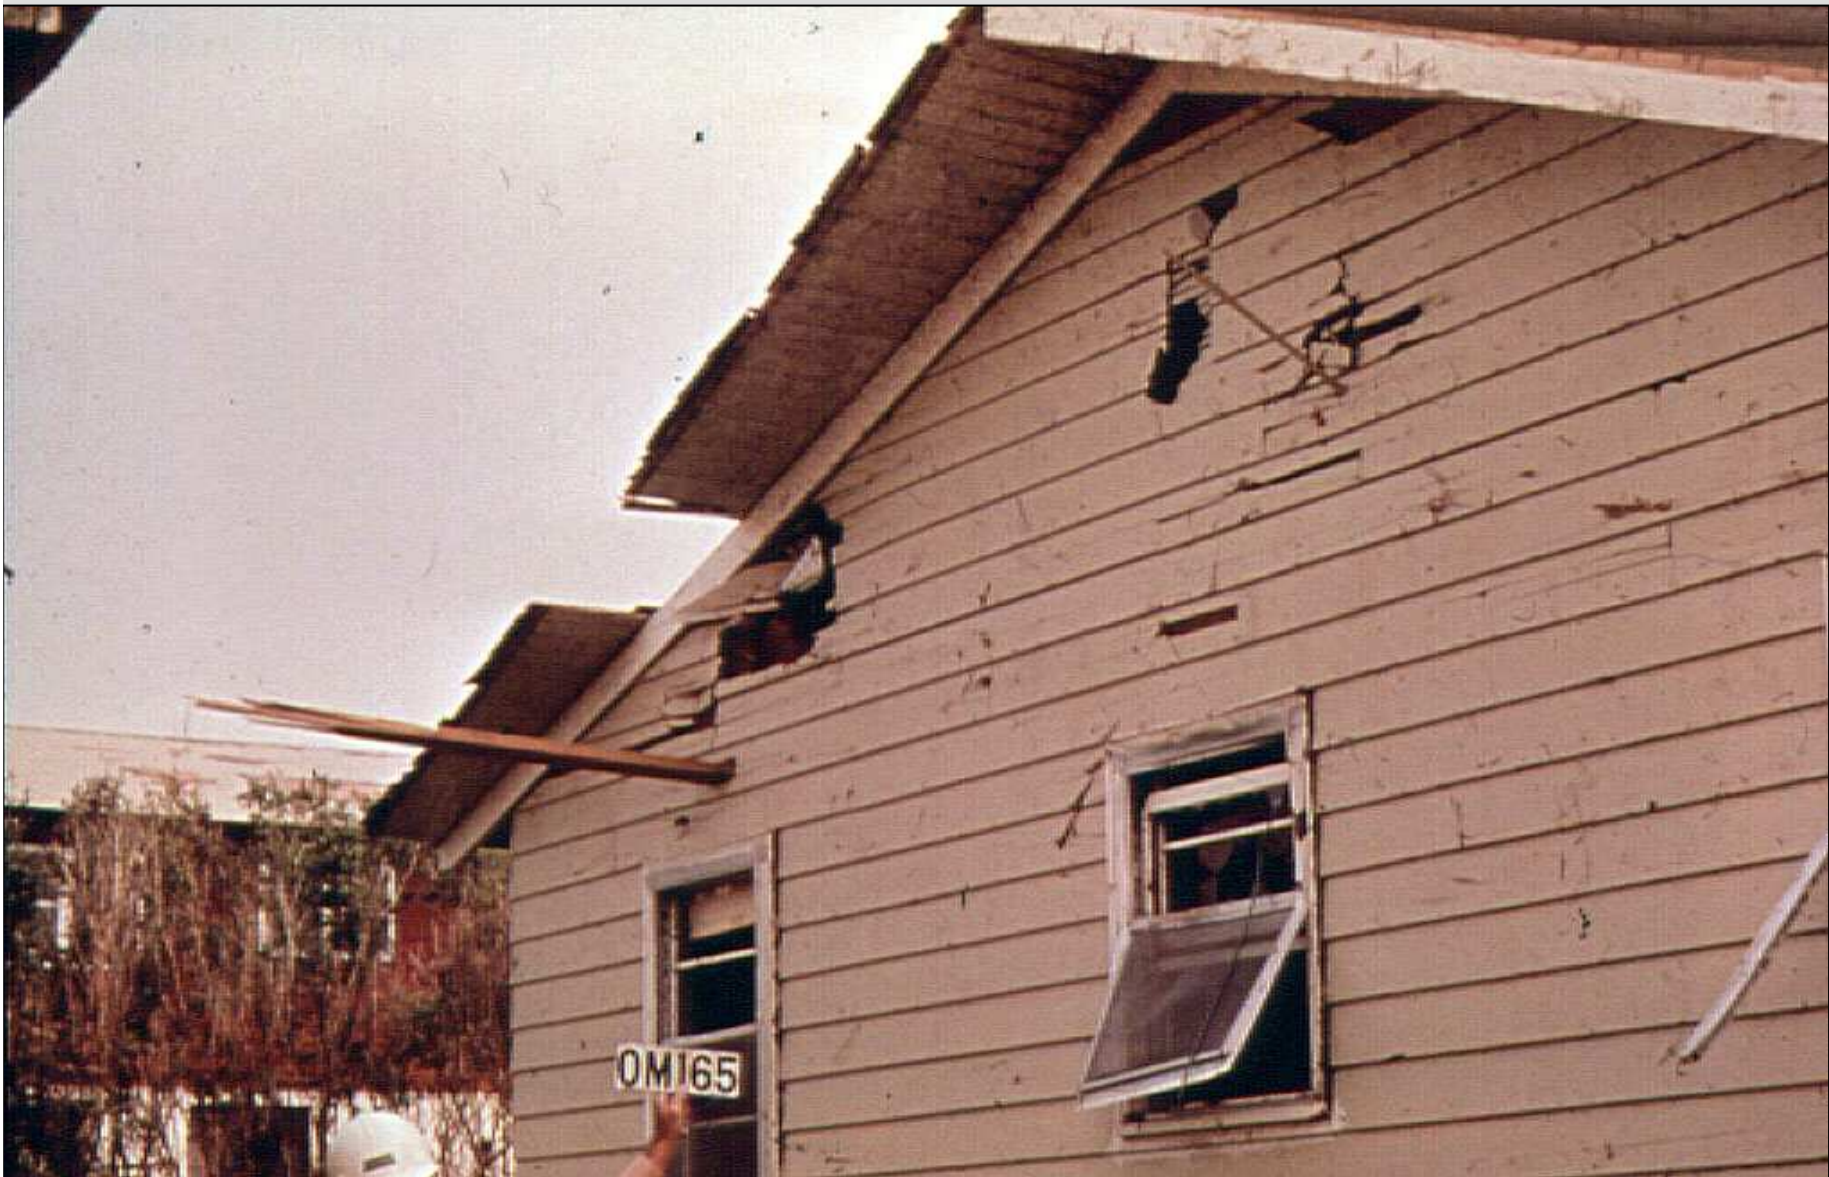
Penetration of wall by flying debris

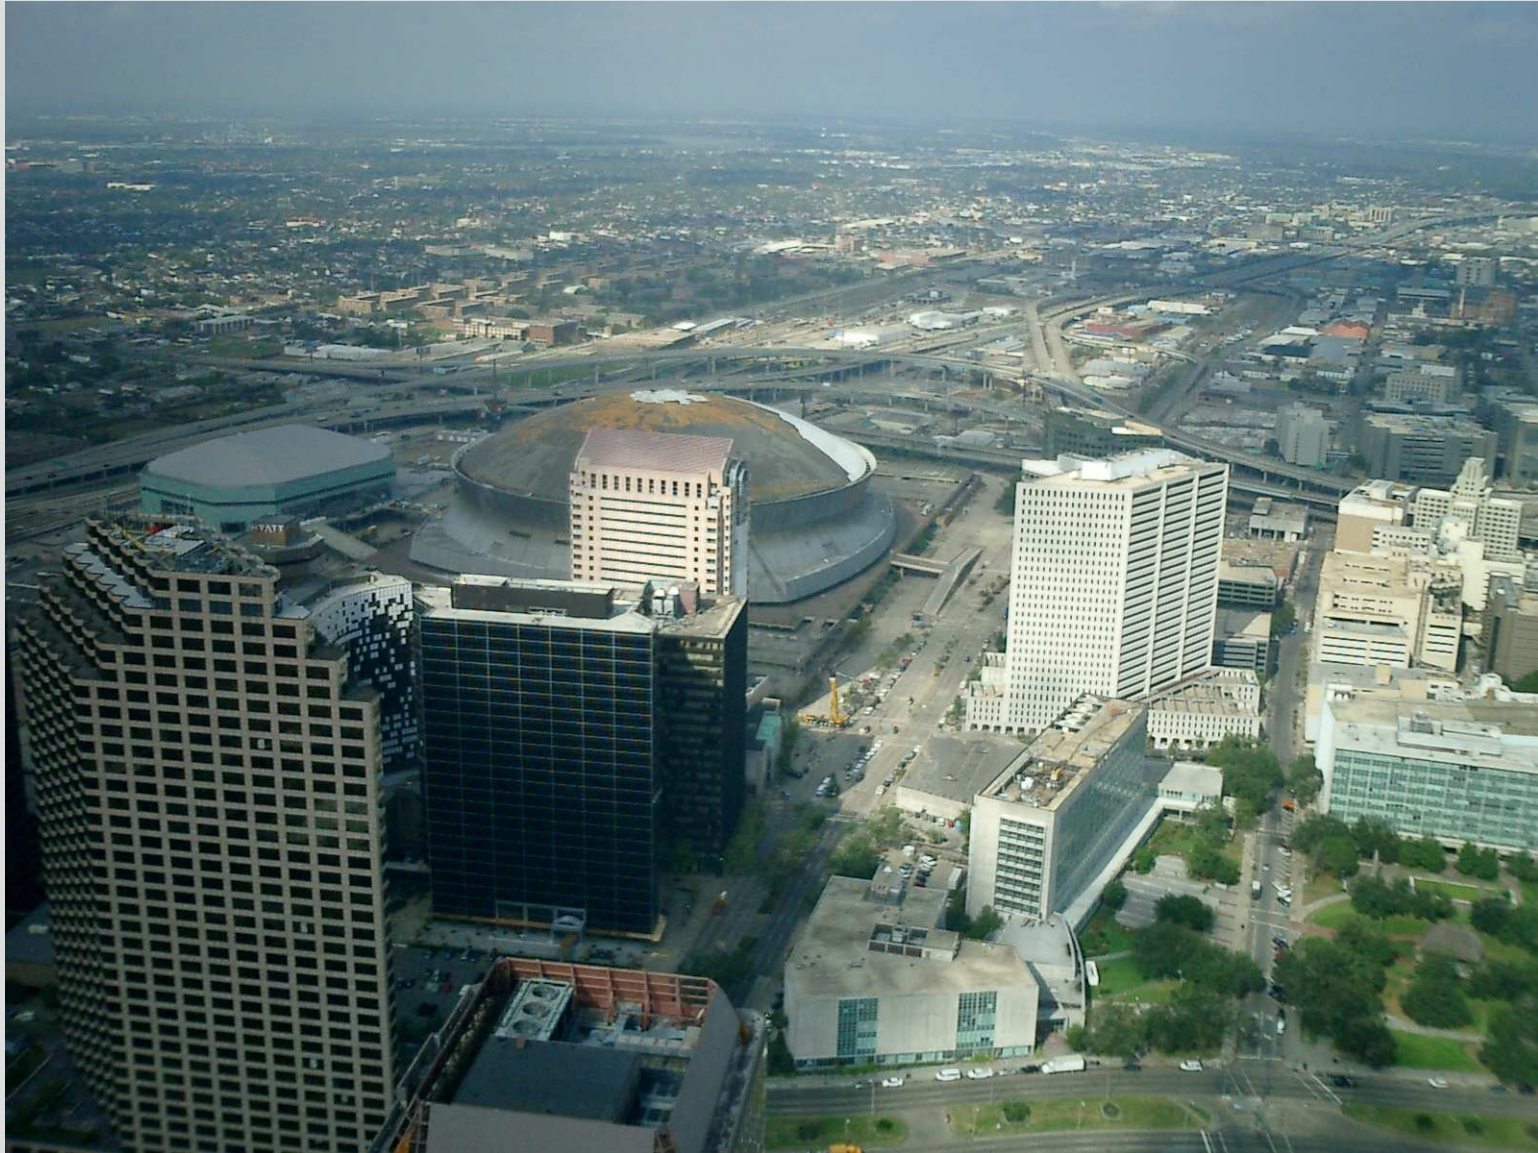
Aerial view showing proximities of debris source buildings and damaged buildings

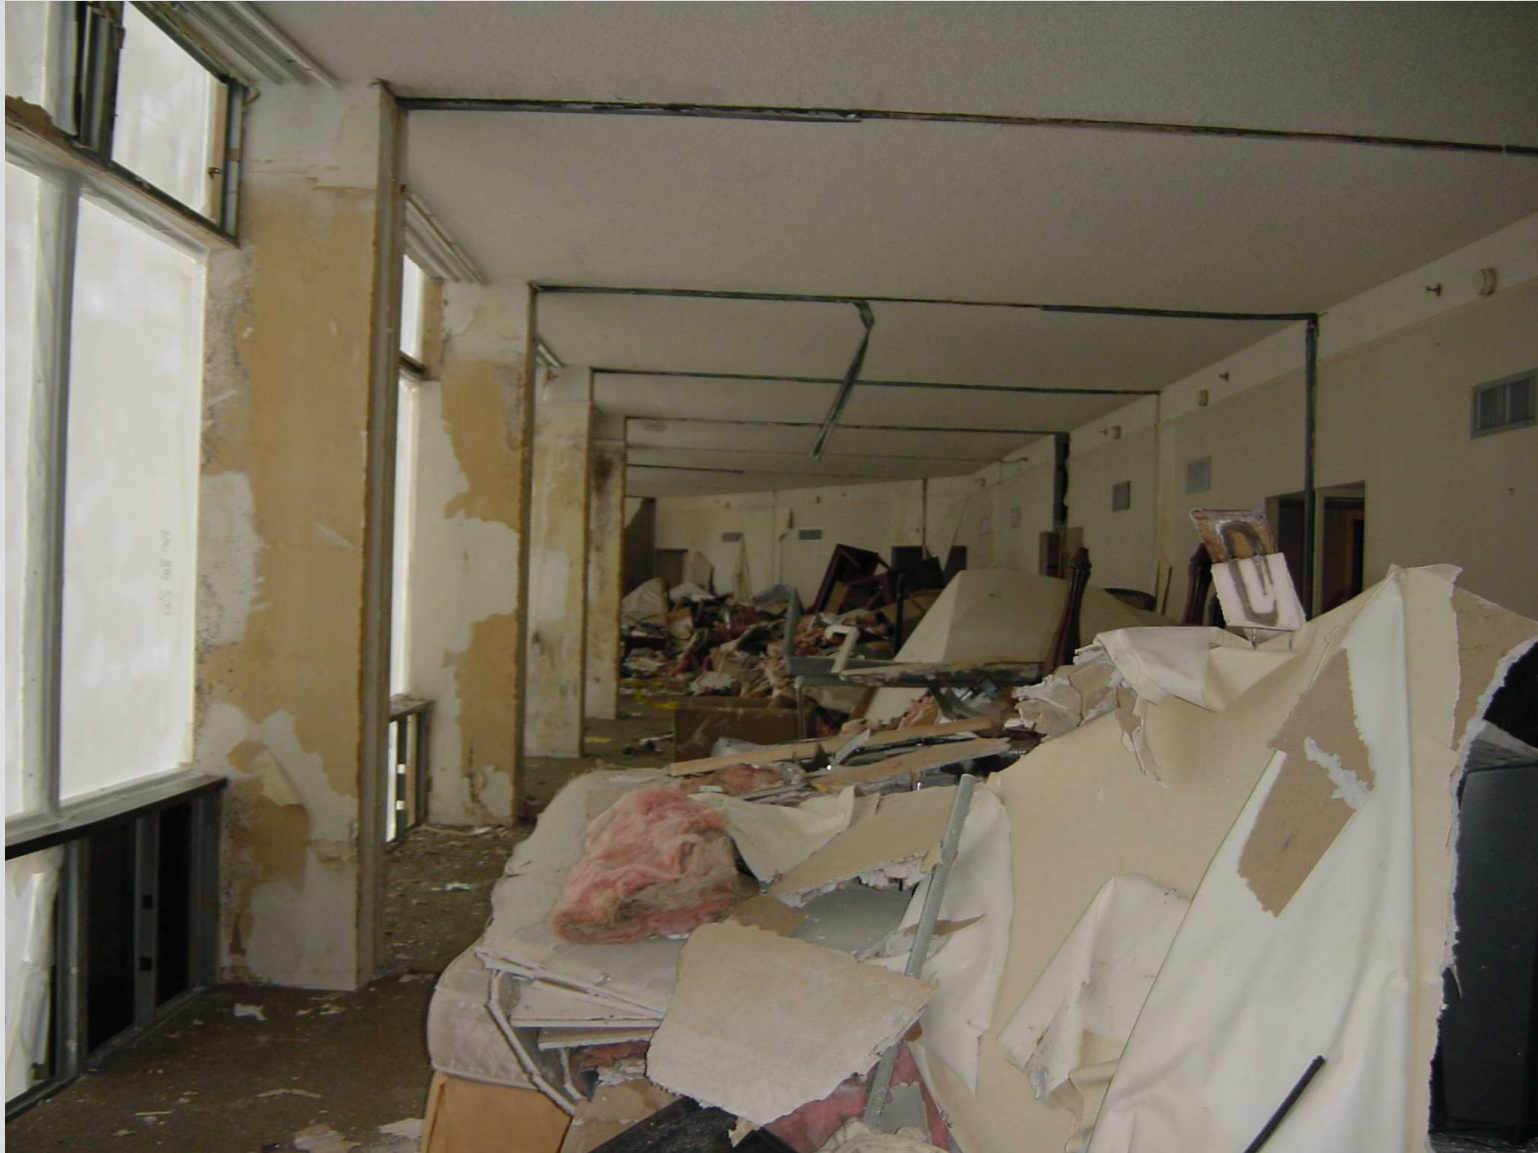
Damage to rooms on north face of 27th floor

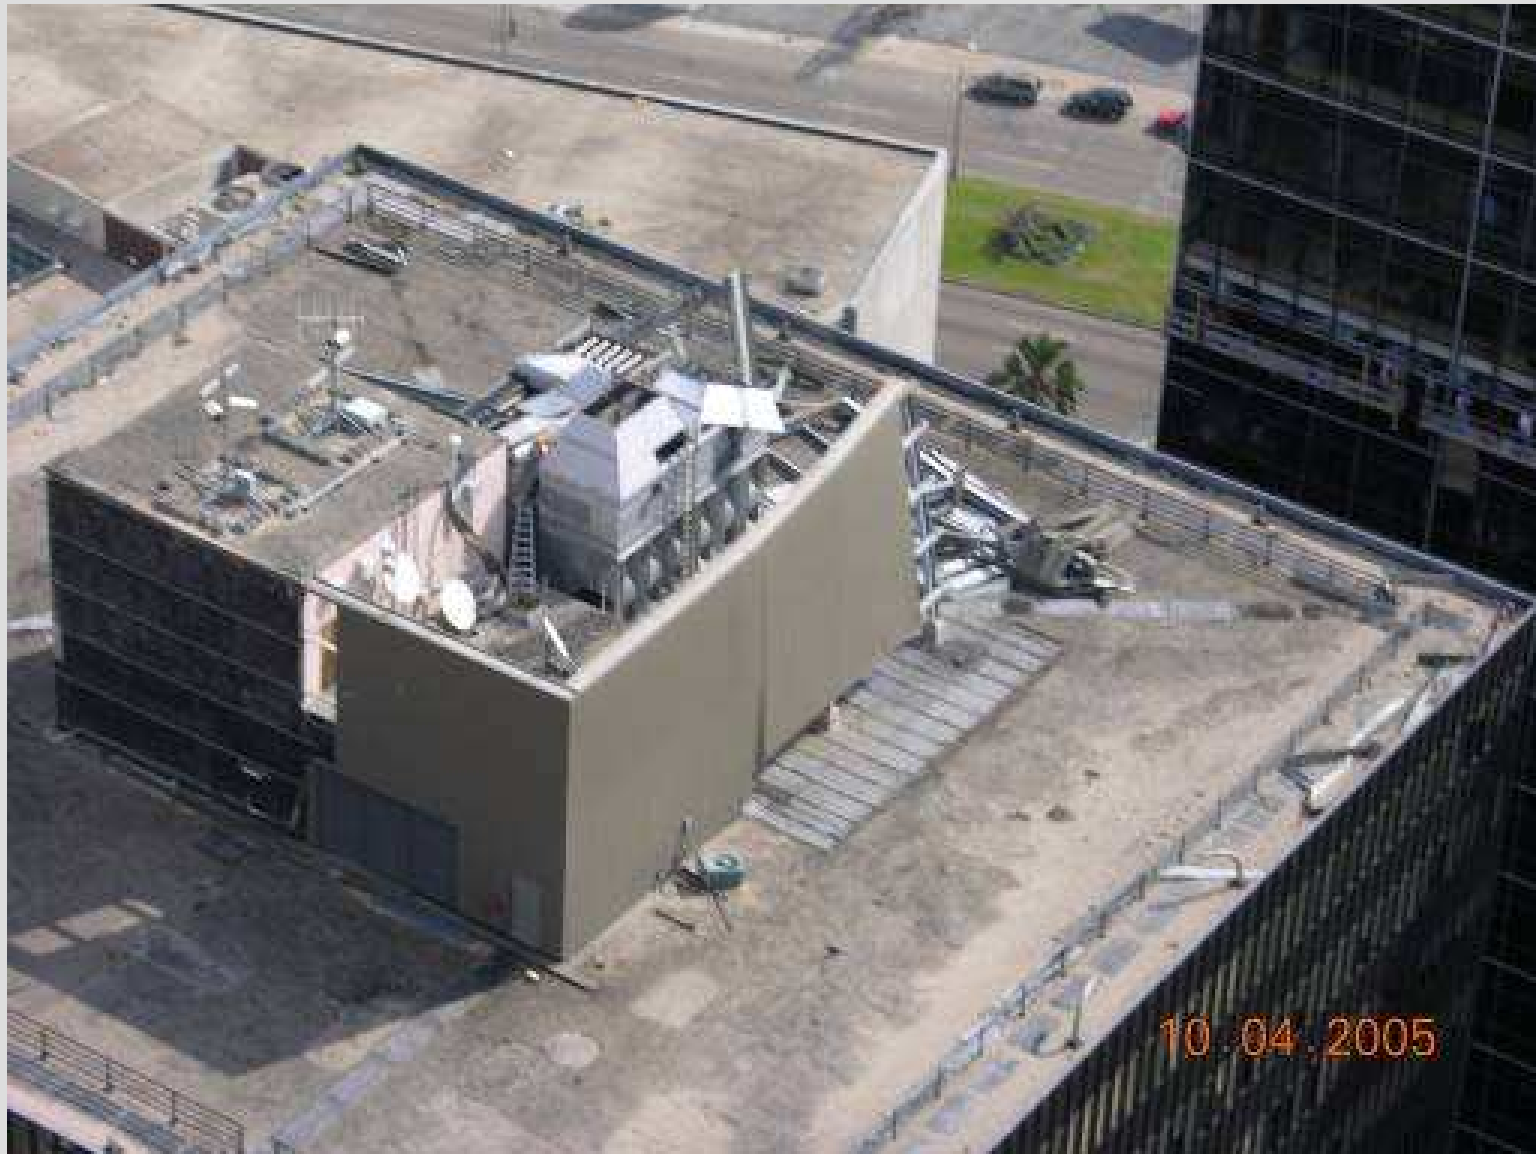
Scoured gravel on Amoco roof, a source of debris causing damage to Hyatt

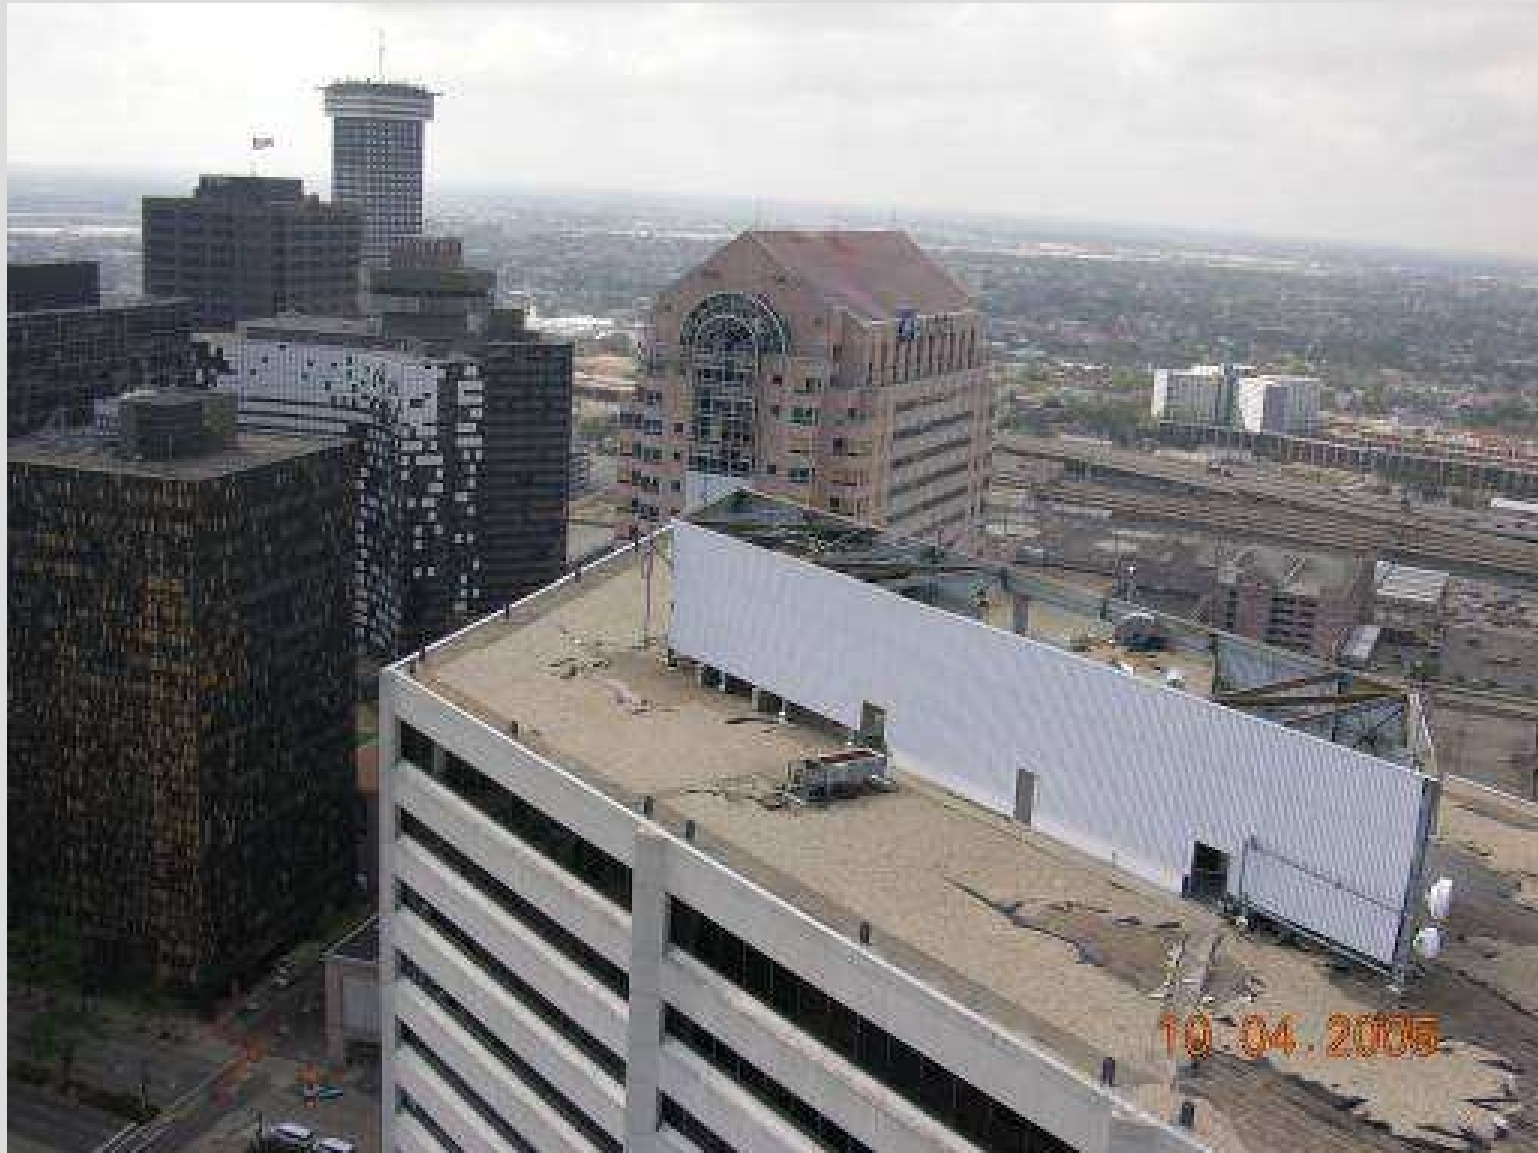
Ballasted single-ply roof - Source of debris causing damage to Amoco and Dominion Bank

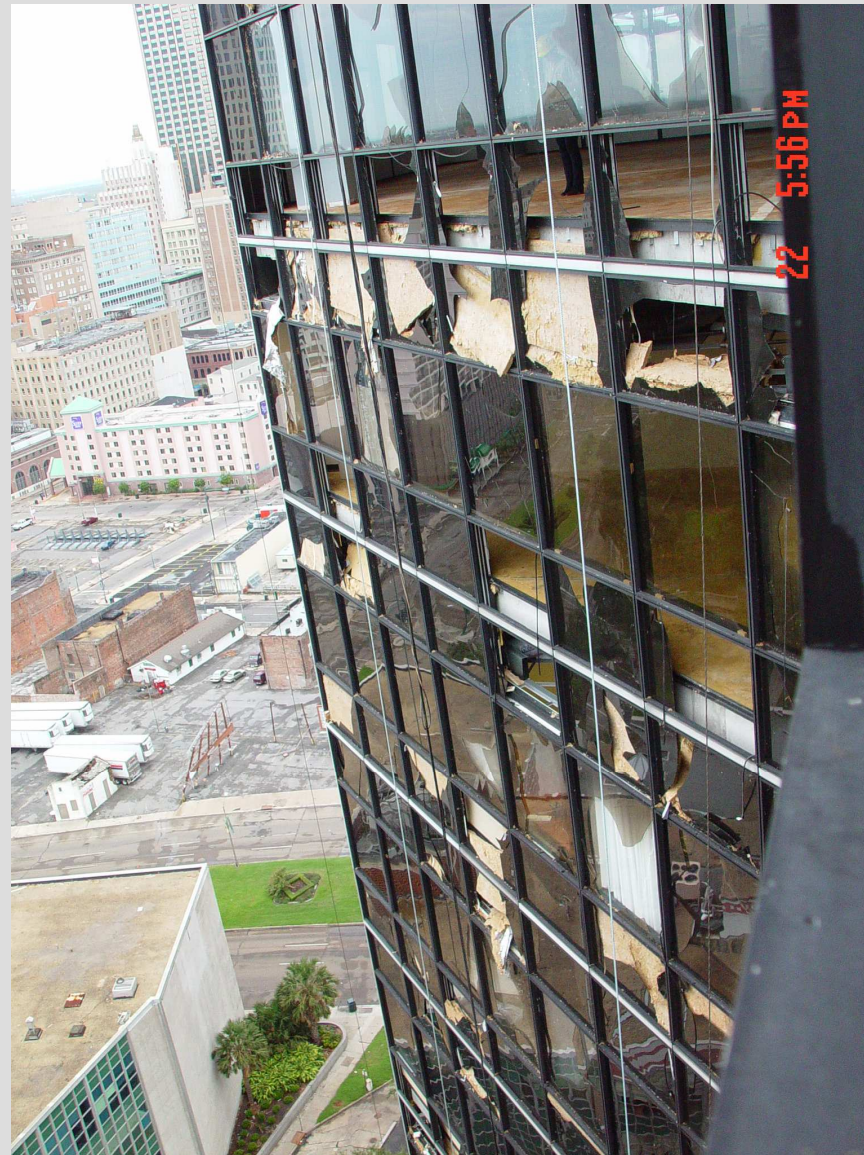
Debris damage to 1250 Poydras, viewed through broken window. Building had 900 broken panes, 200 of which were complete penetrations (both layers of glass were broken)

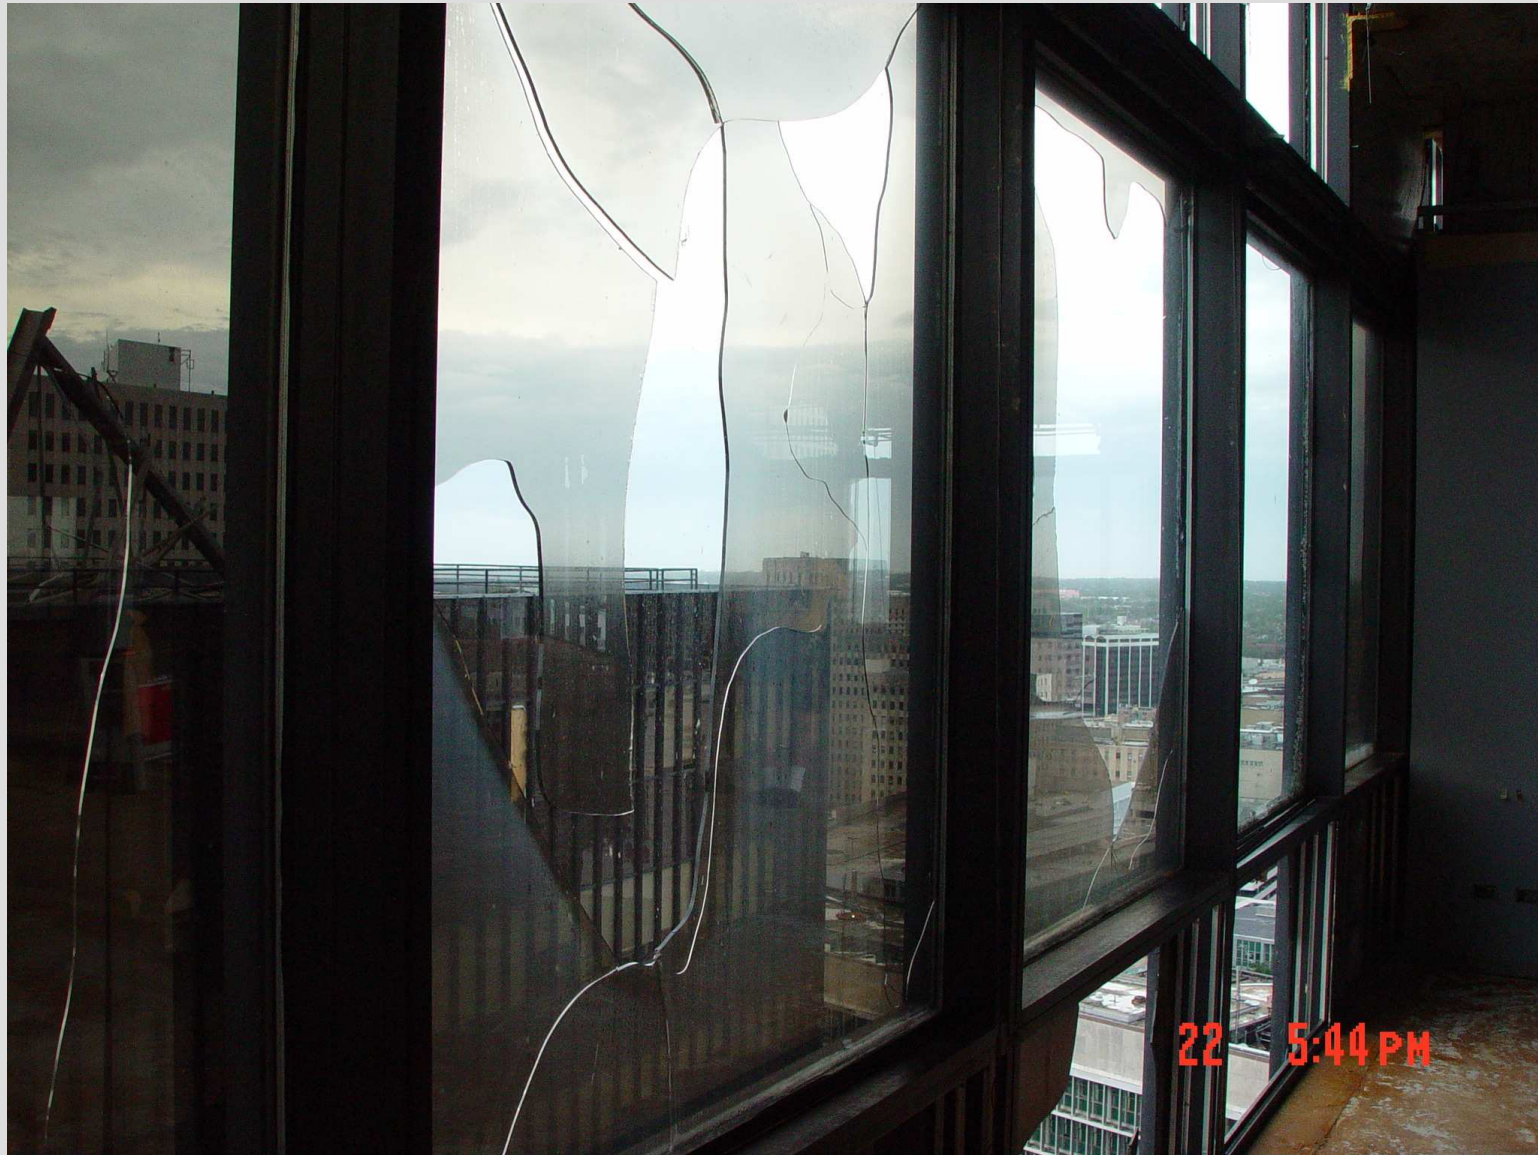
Typical window damage to 1250 Poydras due to wind-borne gravel

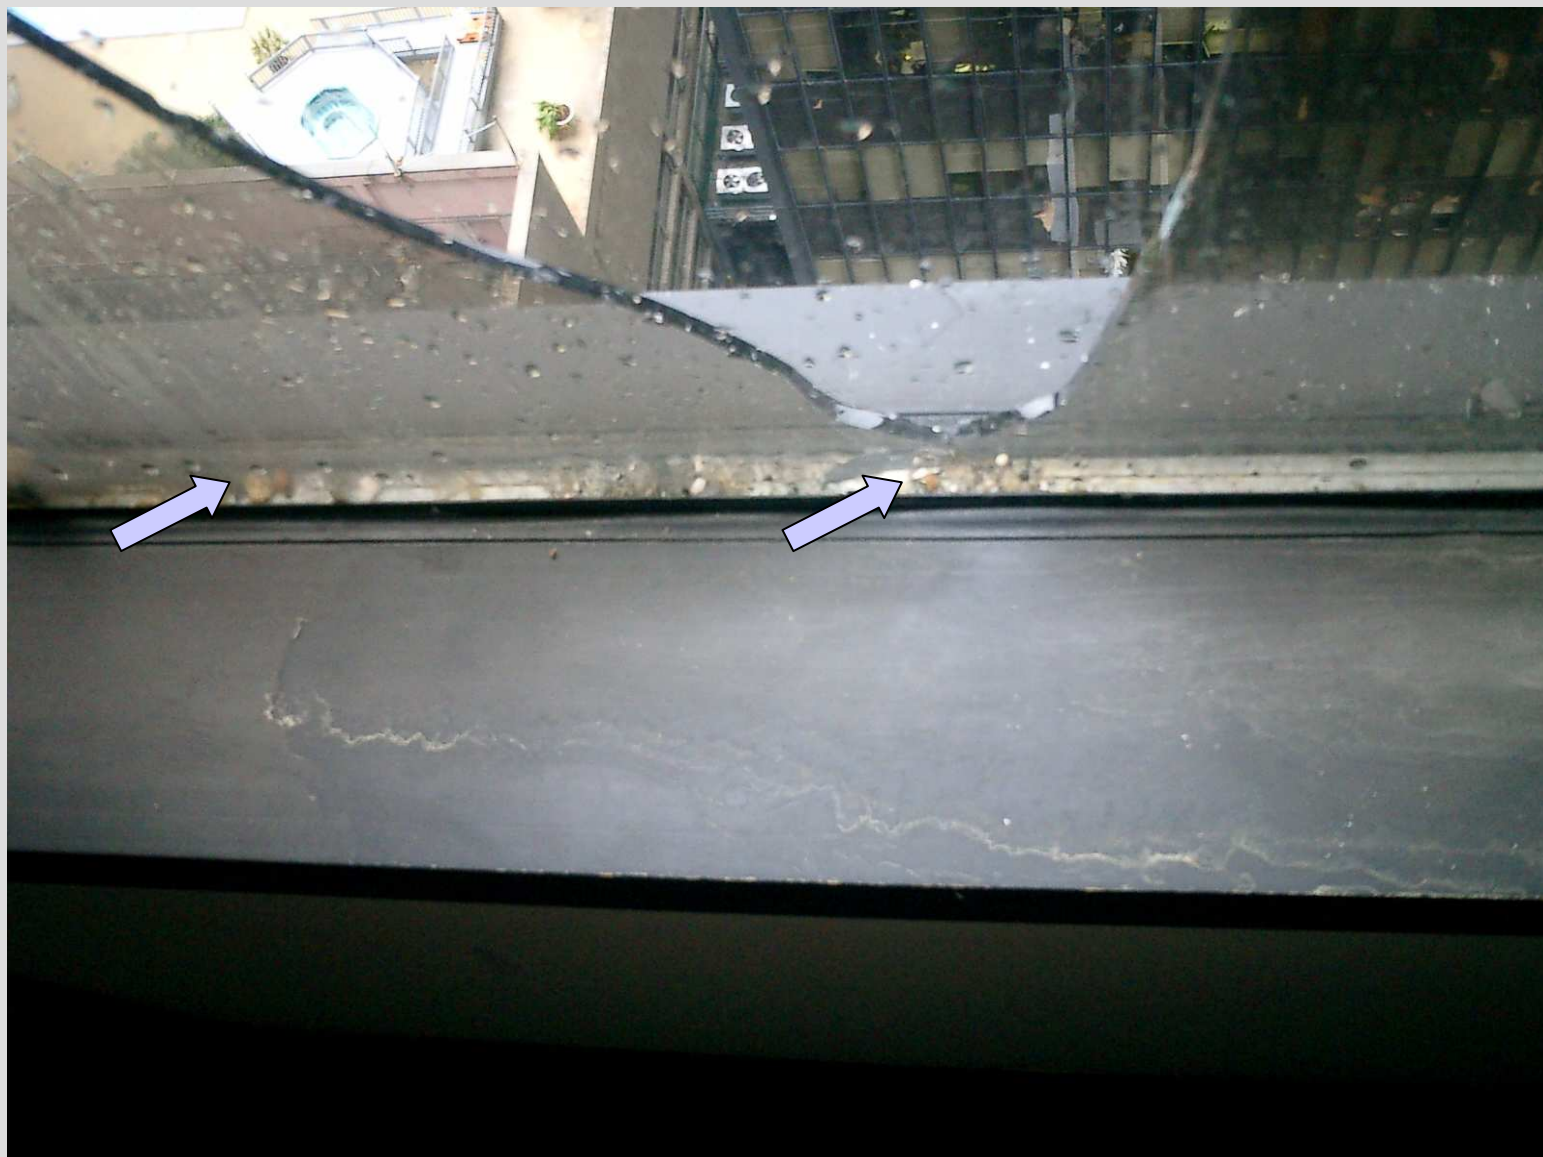
Gravel in the gap between broken outer pane and intact inner pane
