**International Conference
Bibliothèque nationale de France
5-6 March 2009**

**WIND RESISTANCE STRATEGIES
FOR CULTURAL HERITAGE
BUILDINGS IN THE AFTERMATH
OF HURRICANE KATRINA**

Elizabeth C. English, PhD
Associate Professor
University of Waterloo School of Architecture

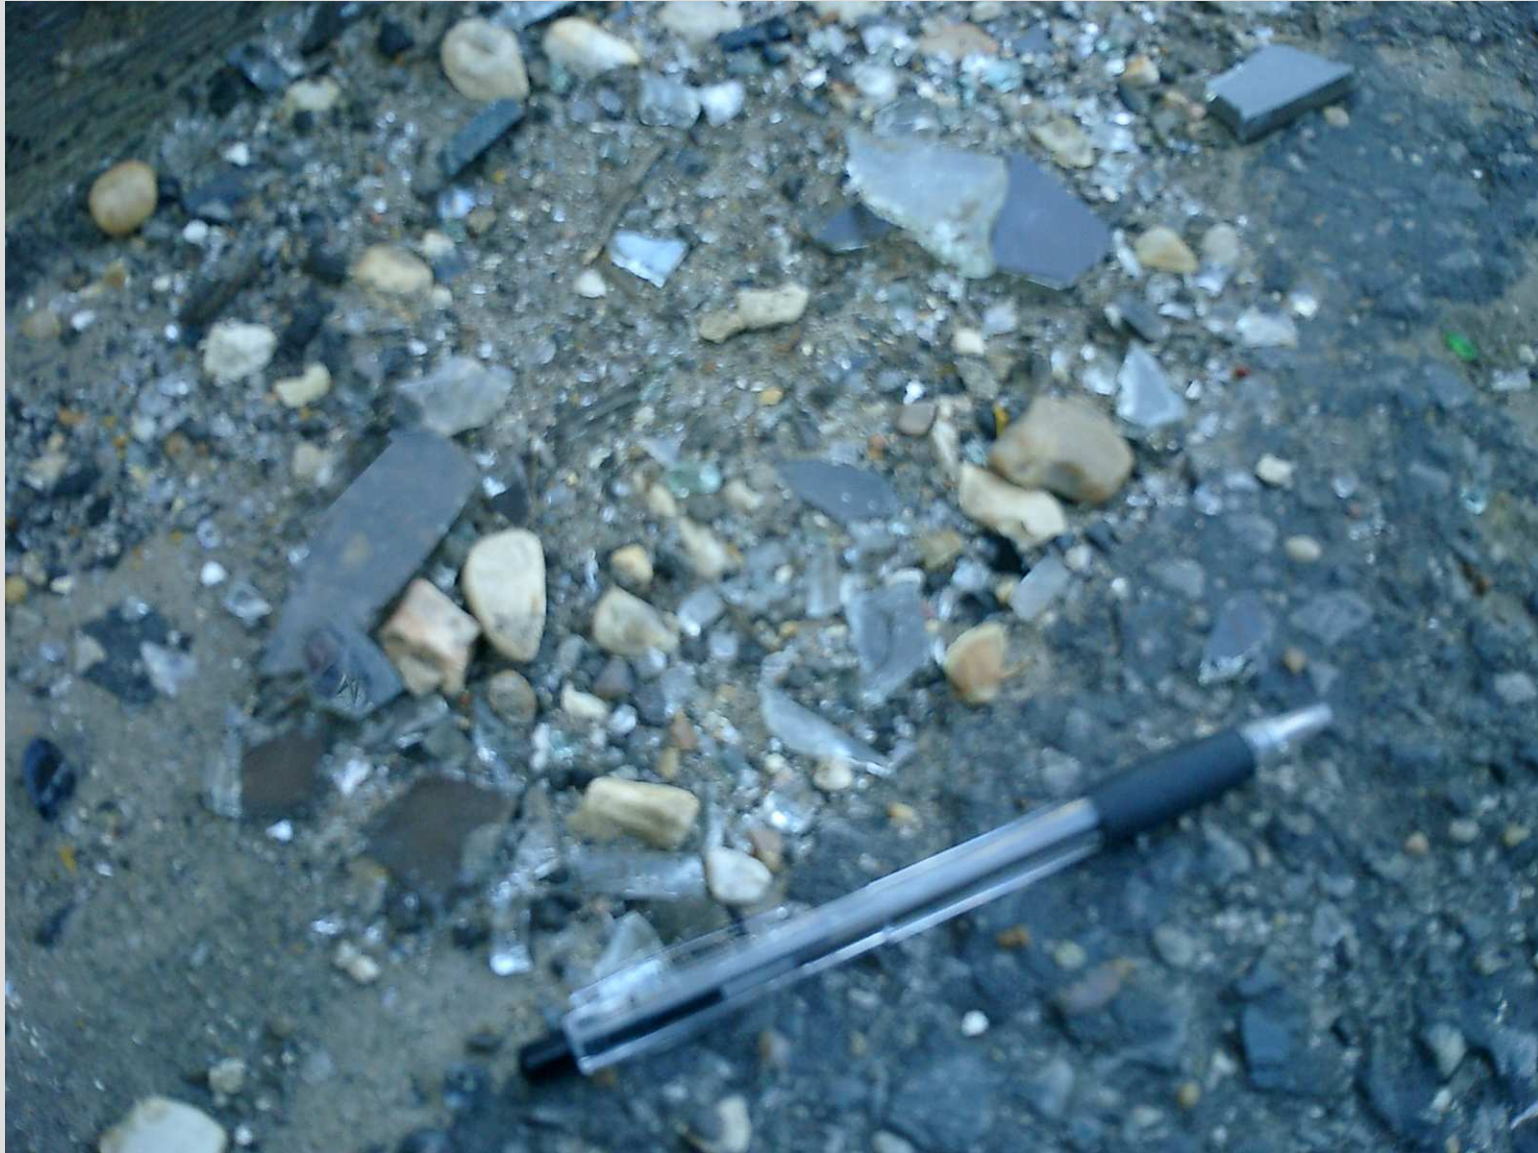
Gravel on sidewalk at base of Amoco

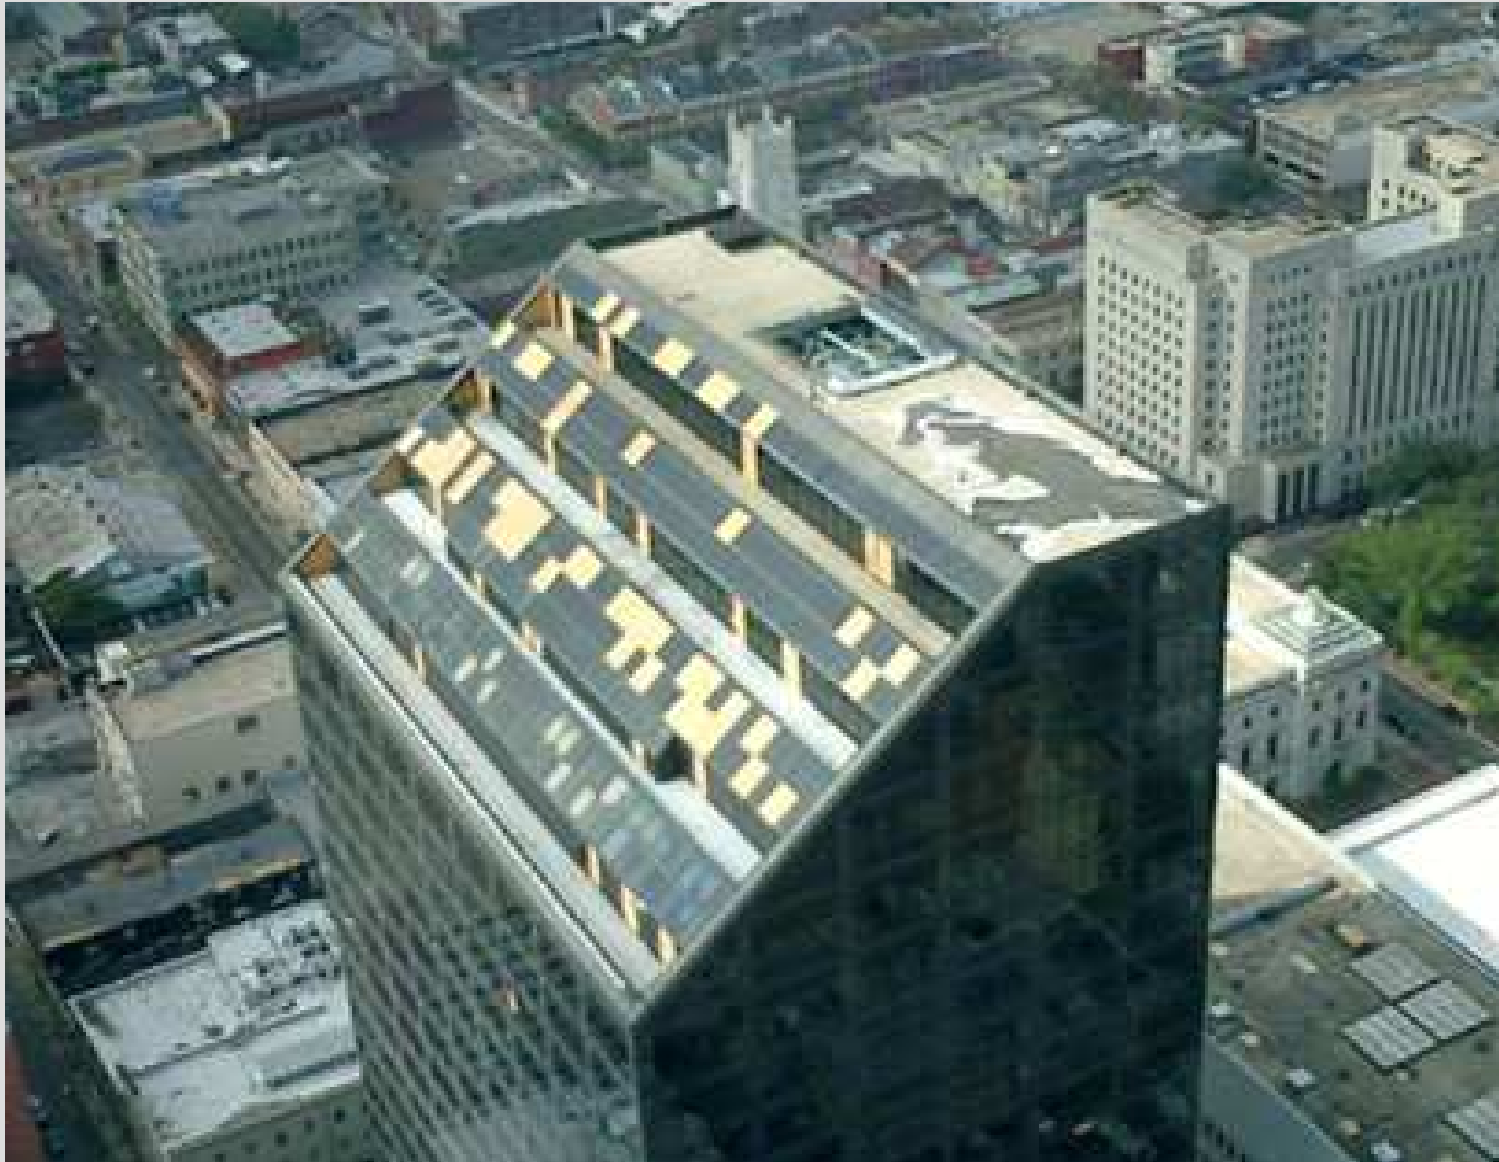
Texaco Building, single-ply ballasted roof, debris source

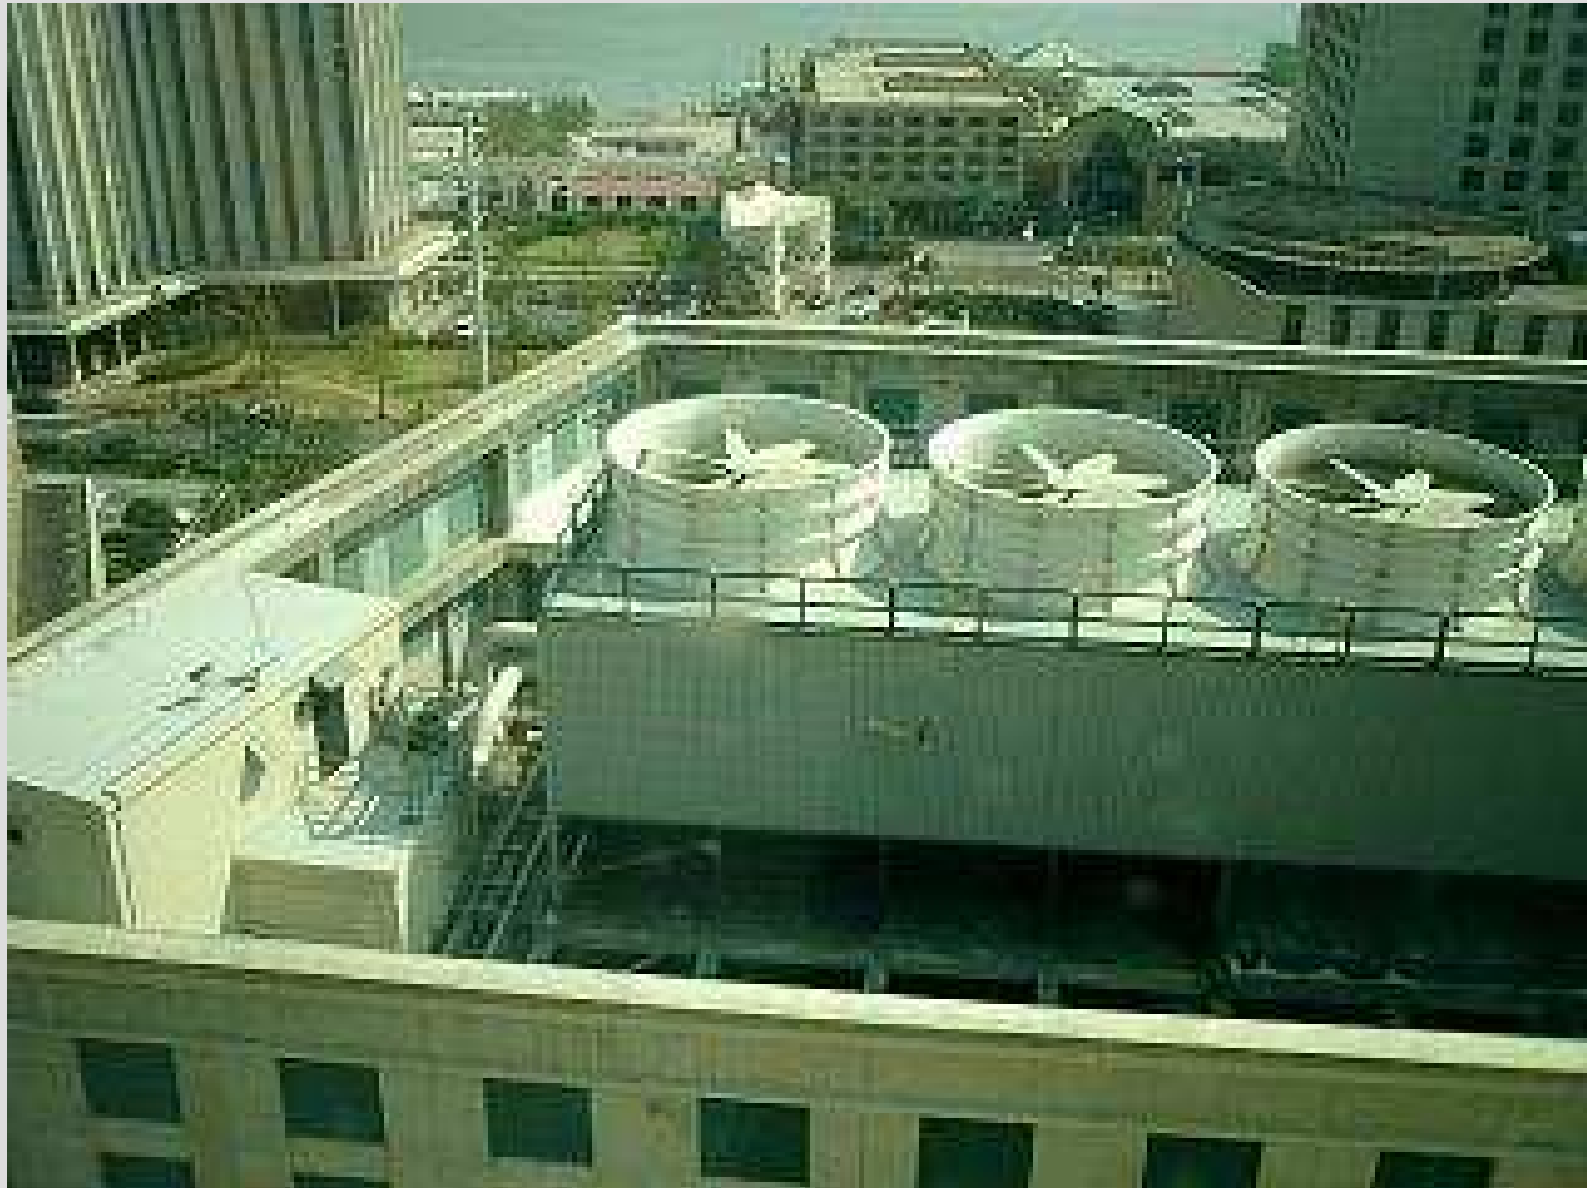
2x4 penetrating cooling tower screen

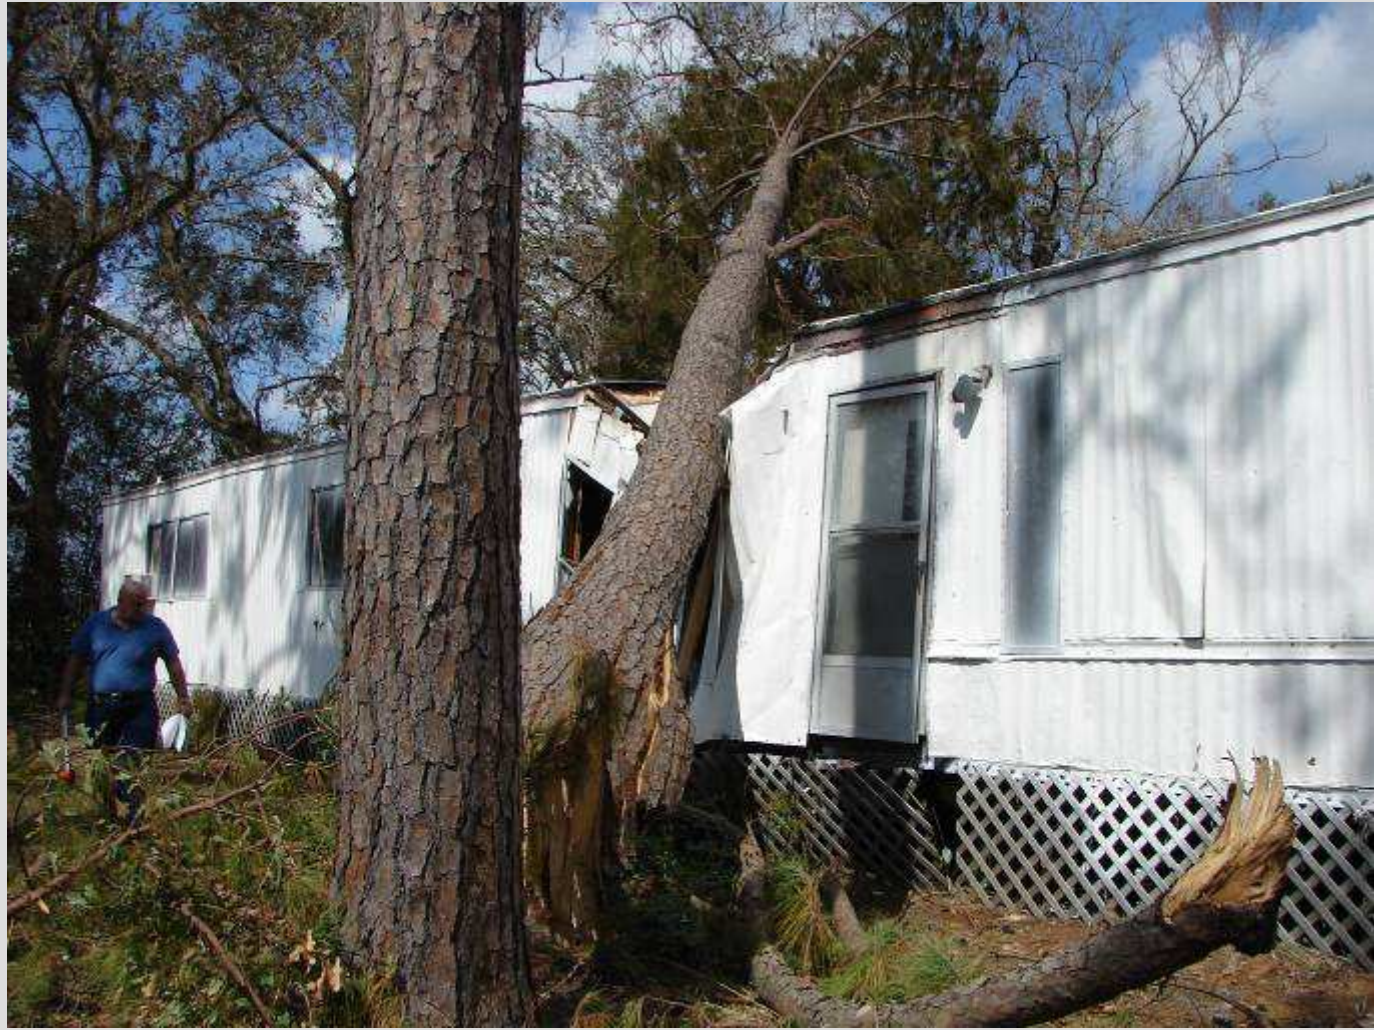
Tree Damage
