**International Conference
Bibliothèque nationale de France
5-6 March 2009**

**WIND RESISTANCE STRATEGIES
FOR CULTURAL HERITAGE
BUILDINGS IN THE AFTERMATH
OF HURRICANE KATRINA**

Elizabeth C. English, PhD
Associate Professor
University of Waterloo School of Architecture

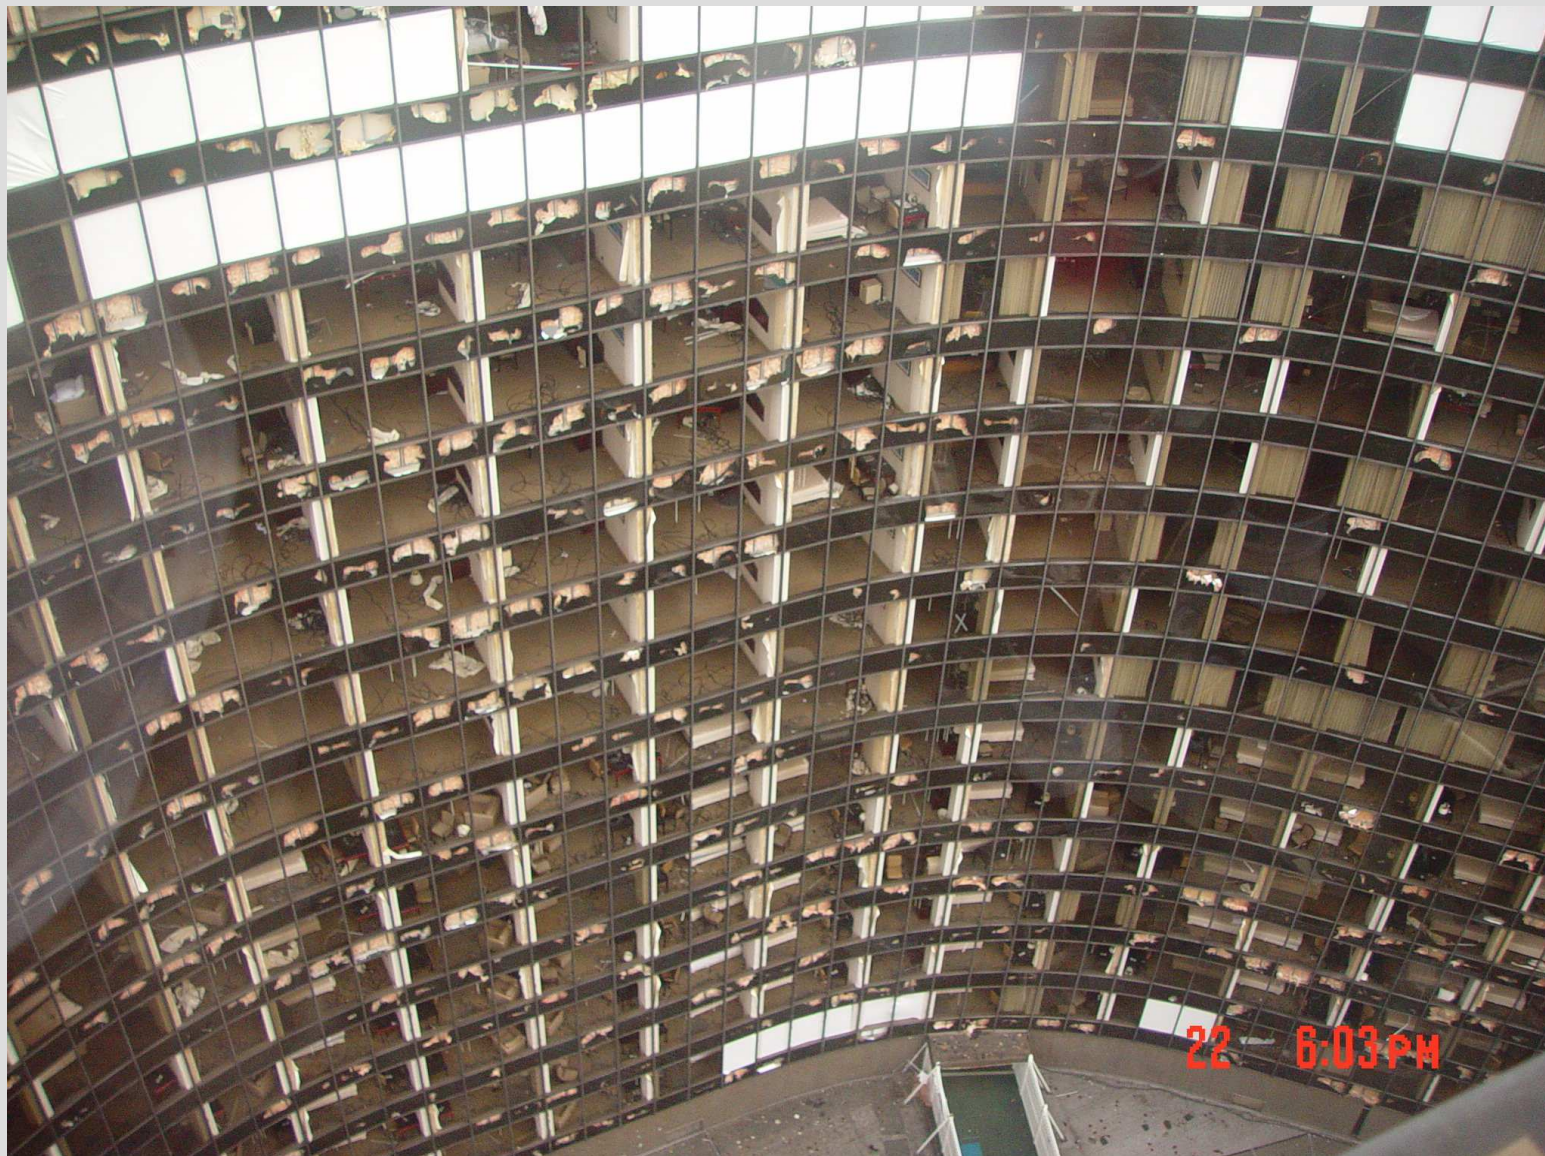
North façade of Hyatt from 1250 Poydras
