**International Conference
Bibliothèque nationale de France
5-6 March 2009**

**WIND RESISTANCE STRATEGIES
FOR CULTURAL HERITAGE
BUILDINGS IN THE AFTERMATH
OF HURRICANE KATRINA**

Elizabeth C. English, PhD
Associate Professor
University of Waterloo School of Architecture

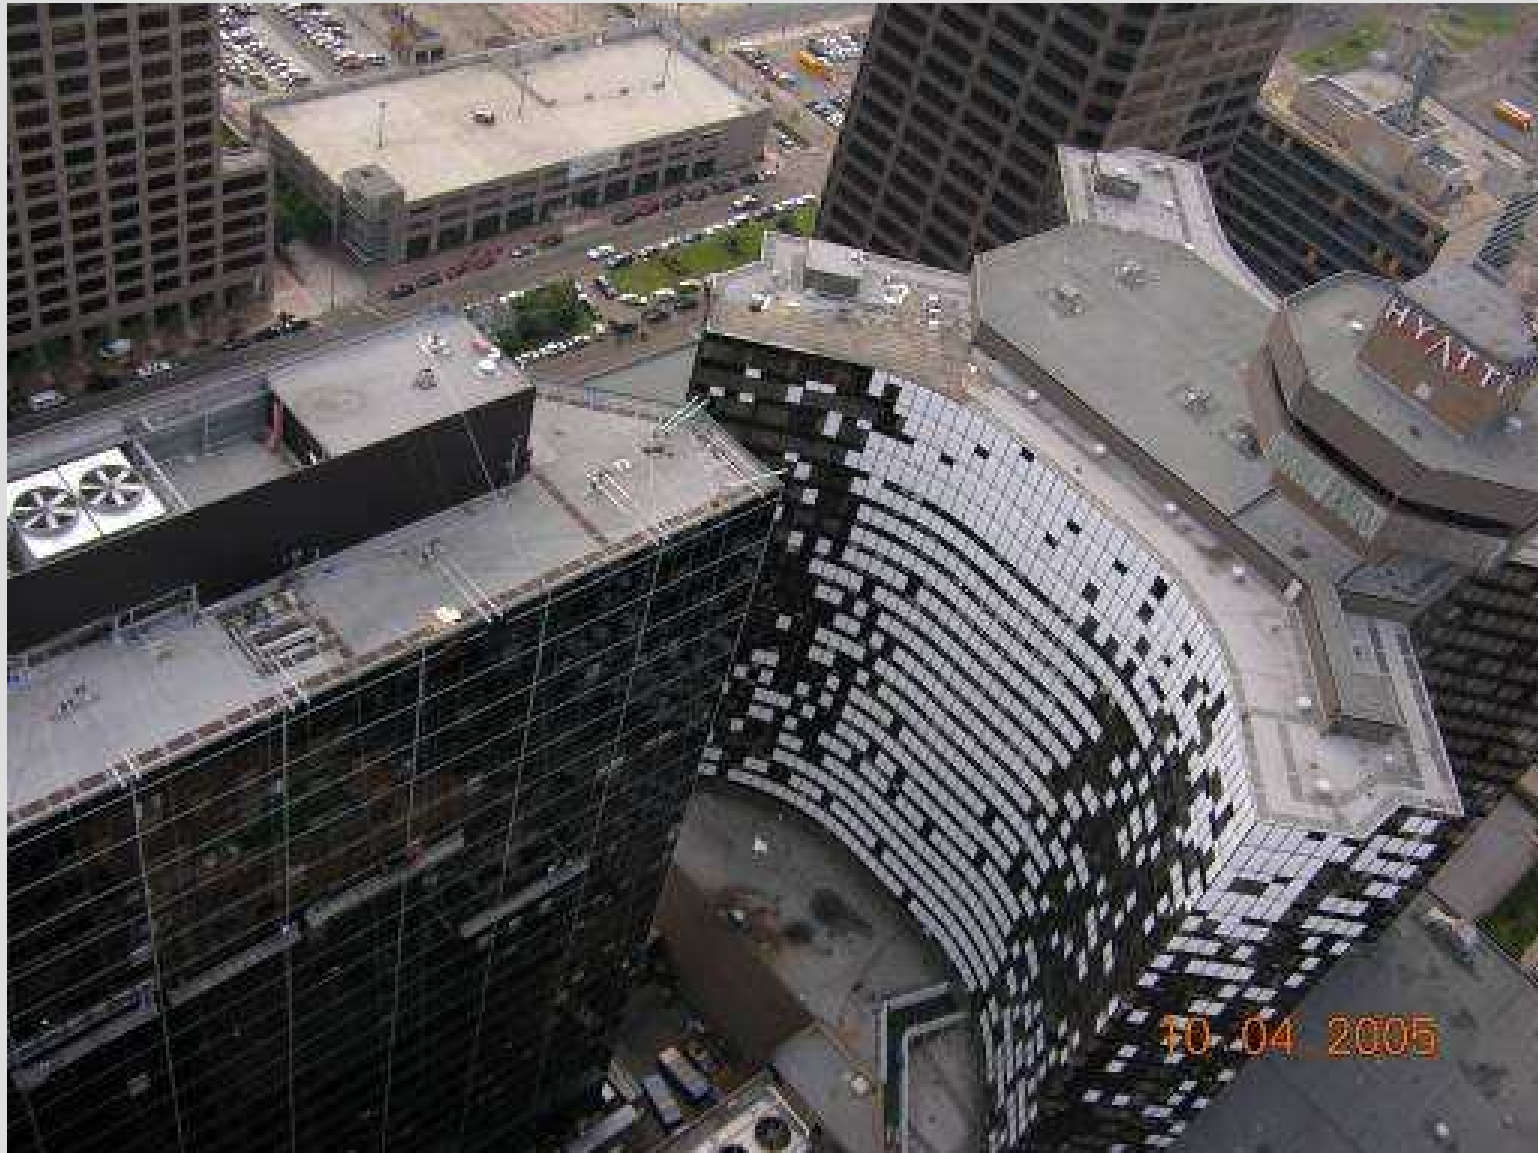
Flyover view of Hyatt with 1250 Poydras in foreground

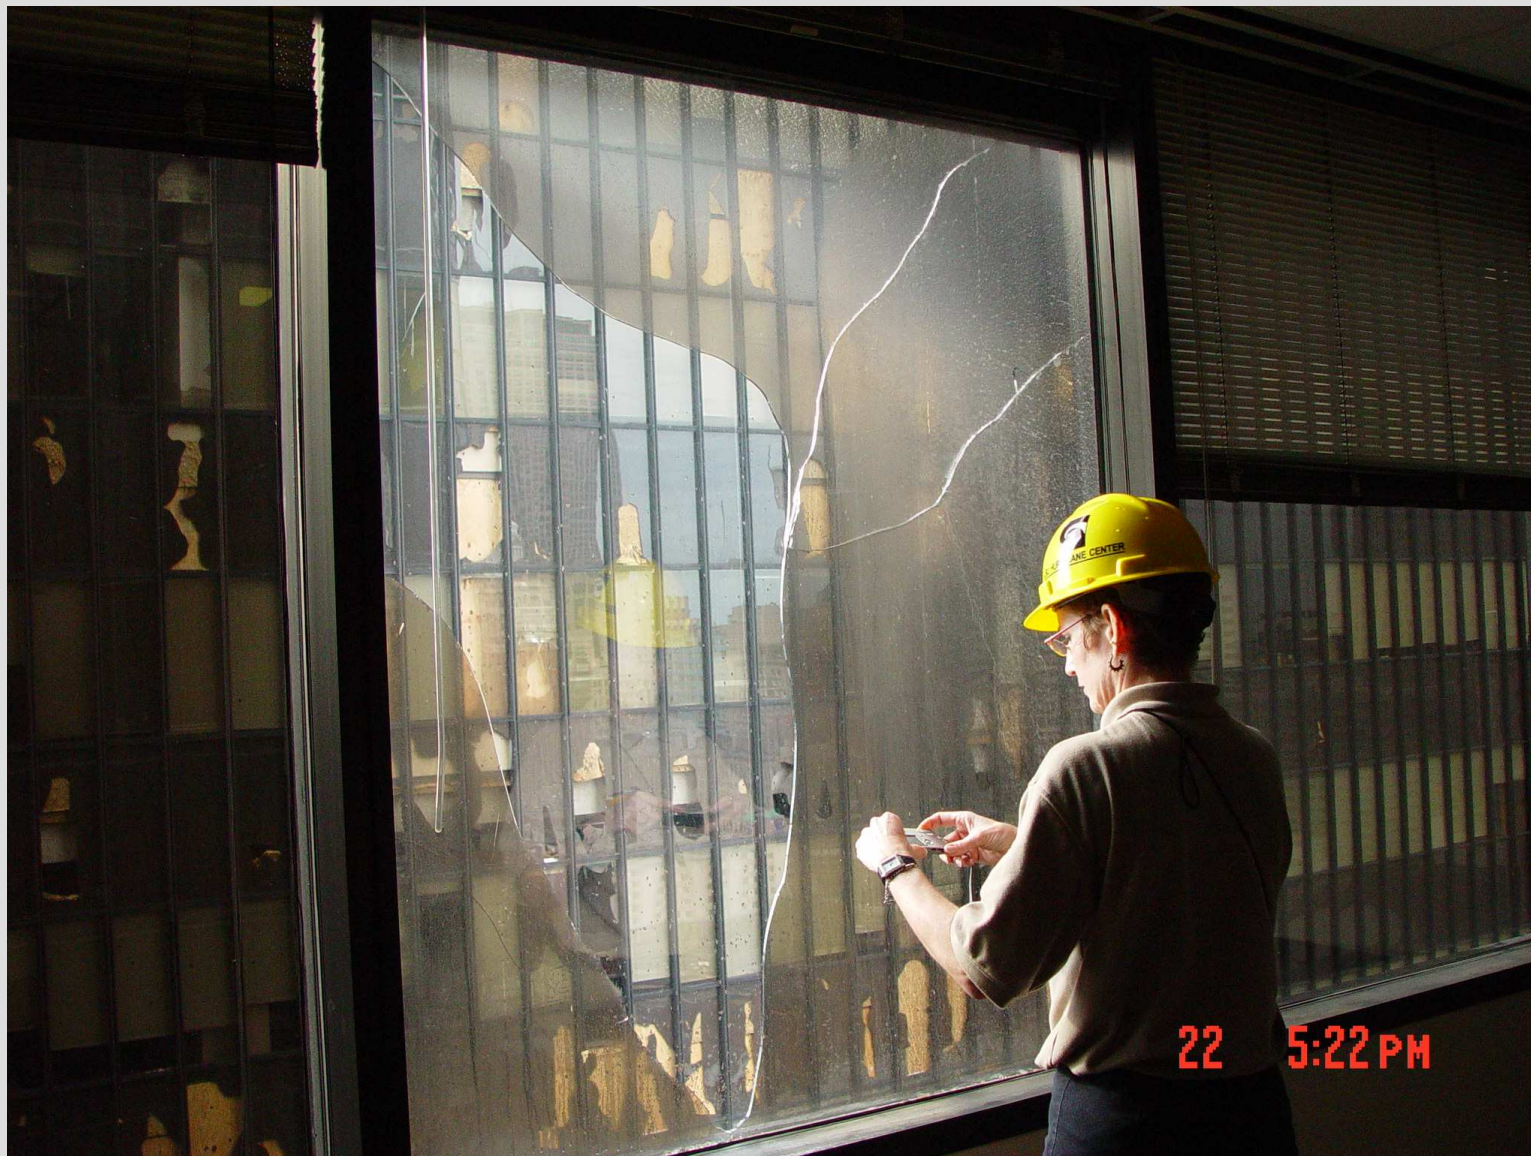
Documenting gravel debris

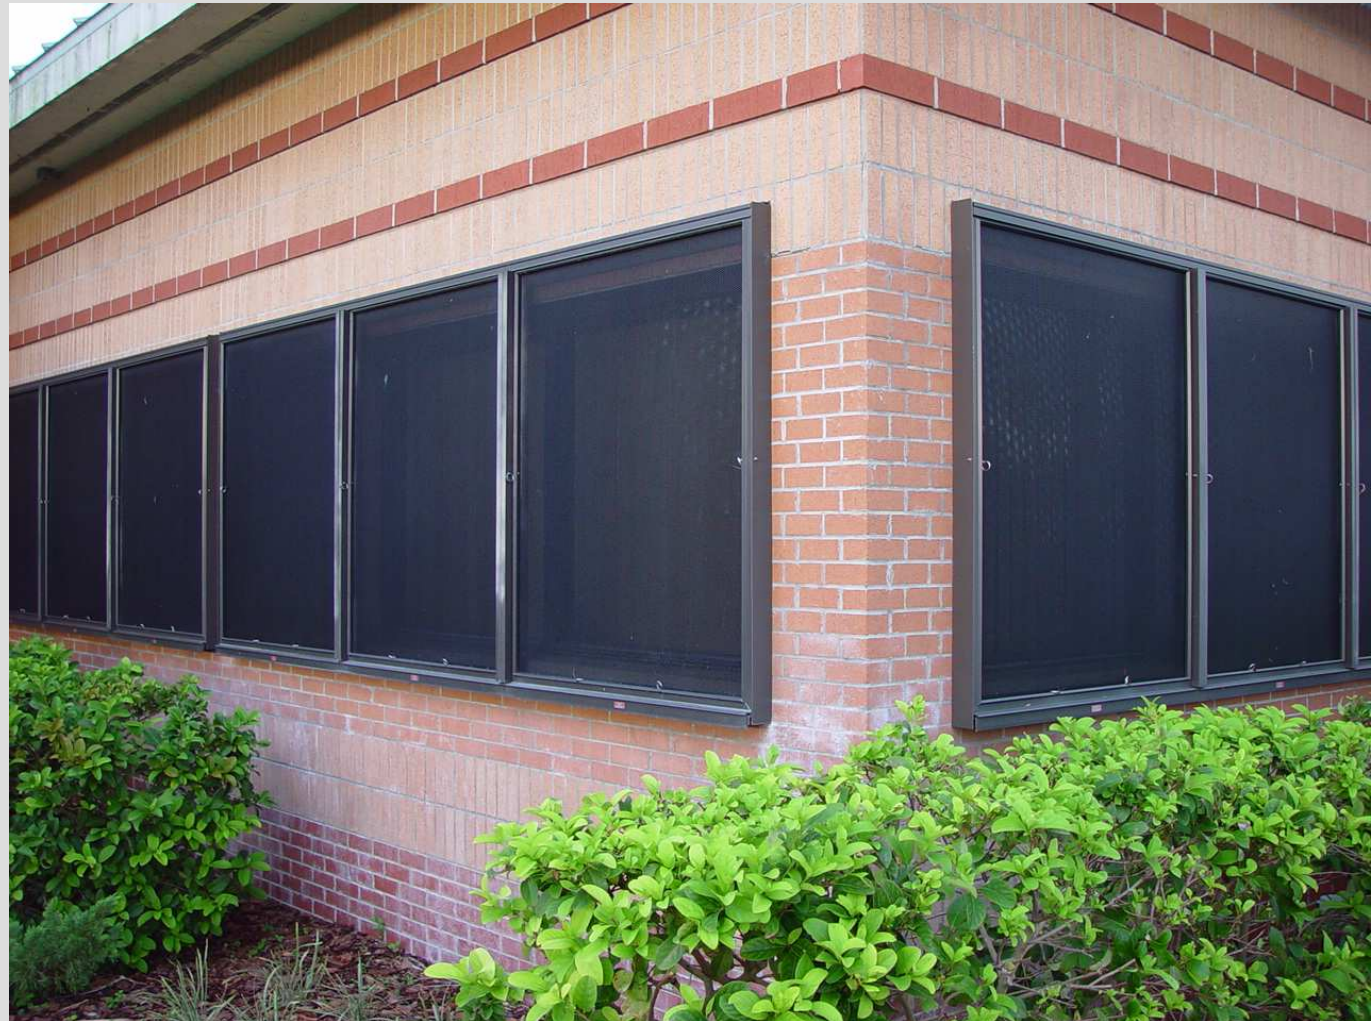
Protection from wind-borne debris

Metal screens

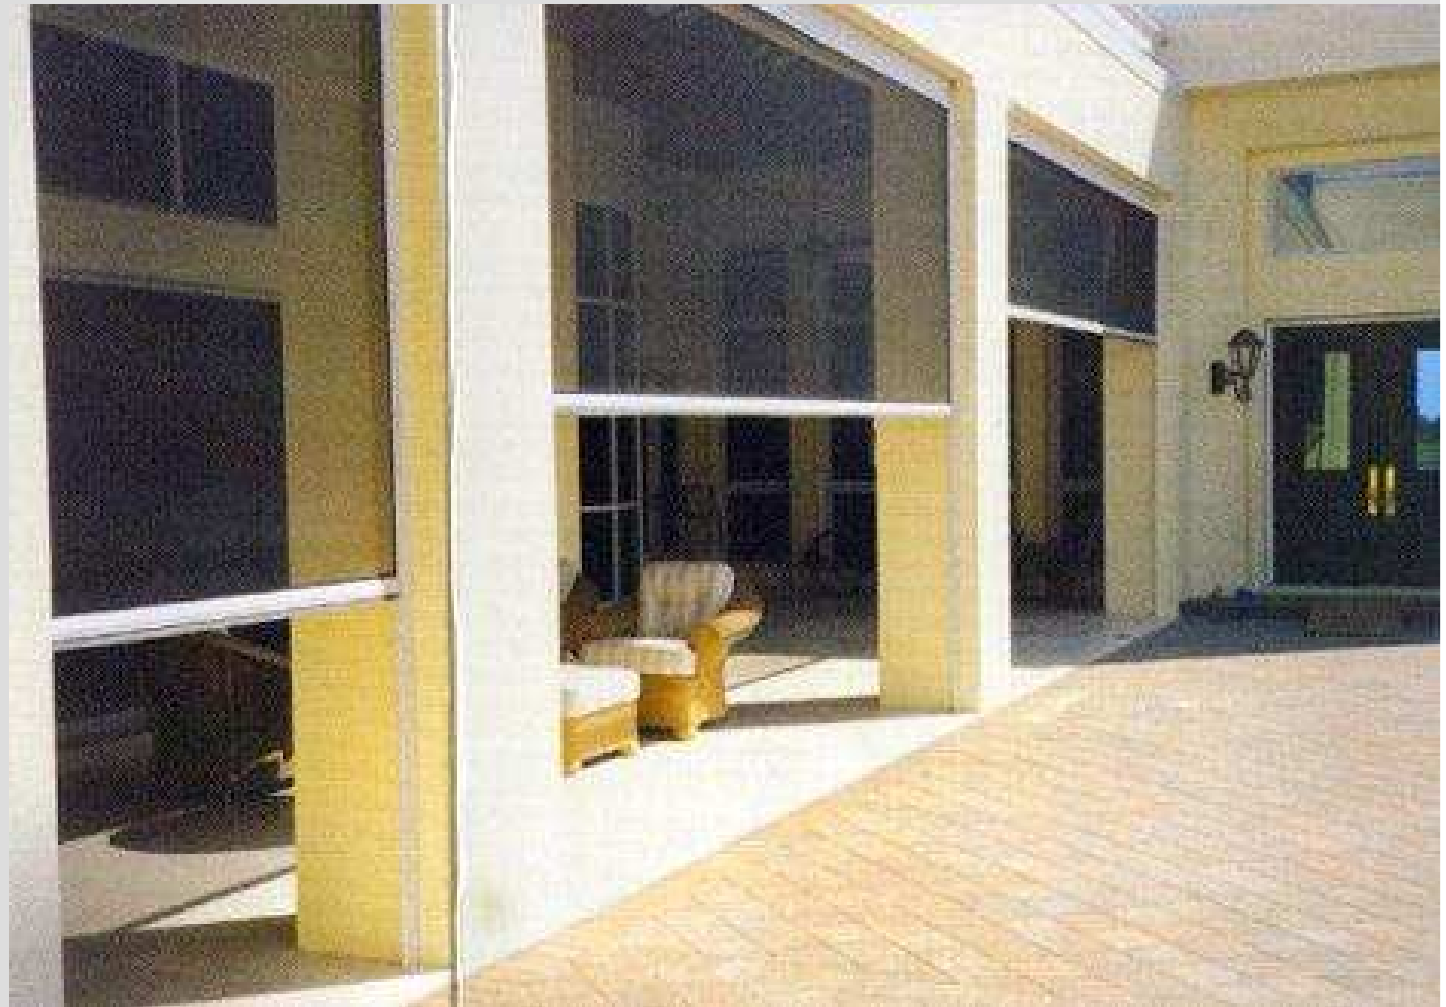
Protection from wind-borne debris

Rolldown perforated metal screen

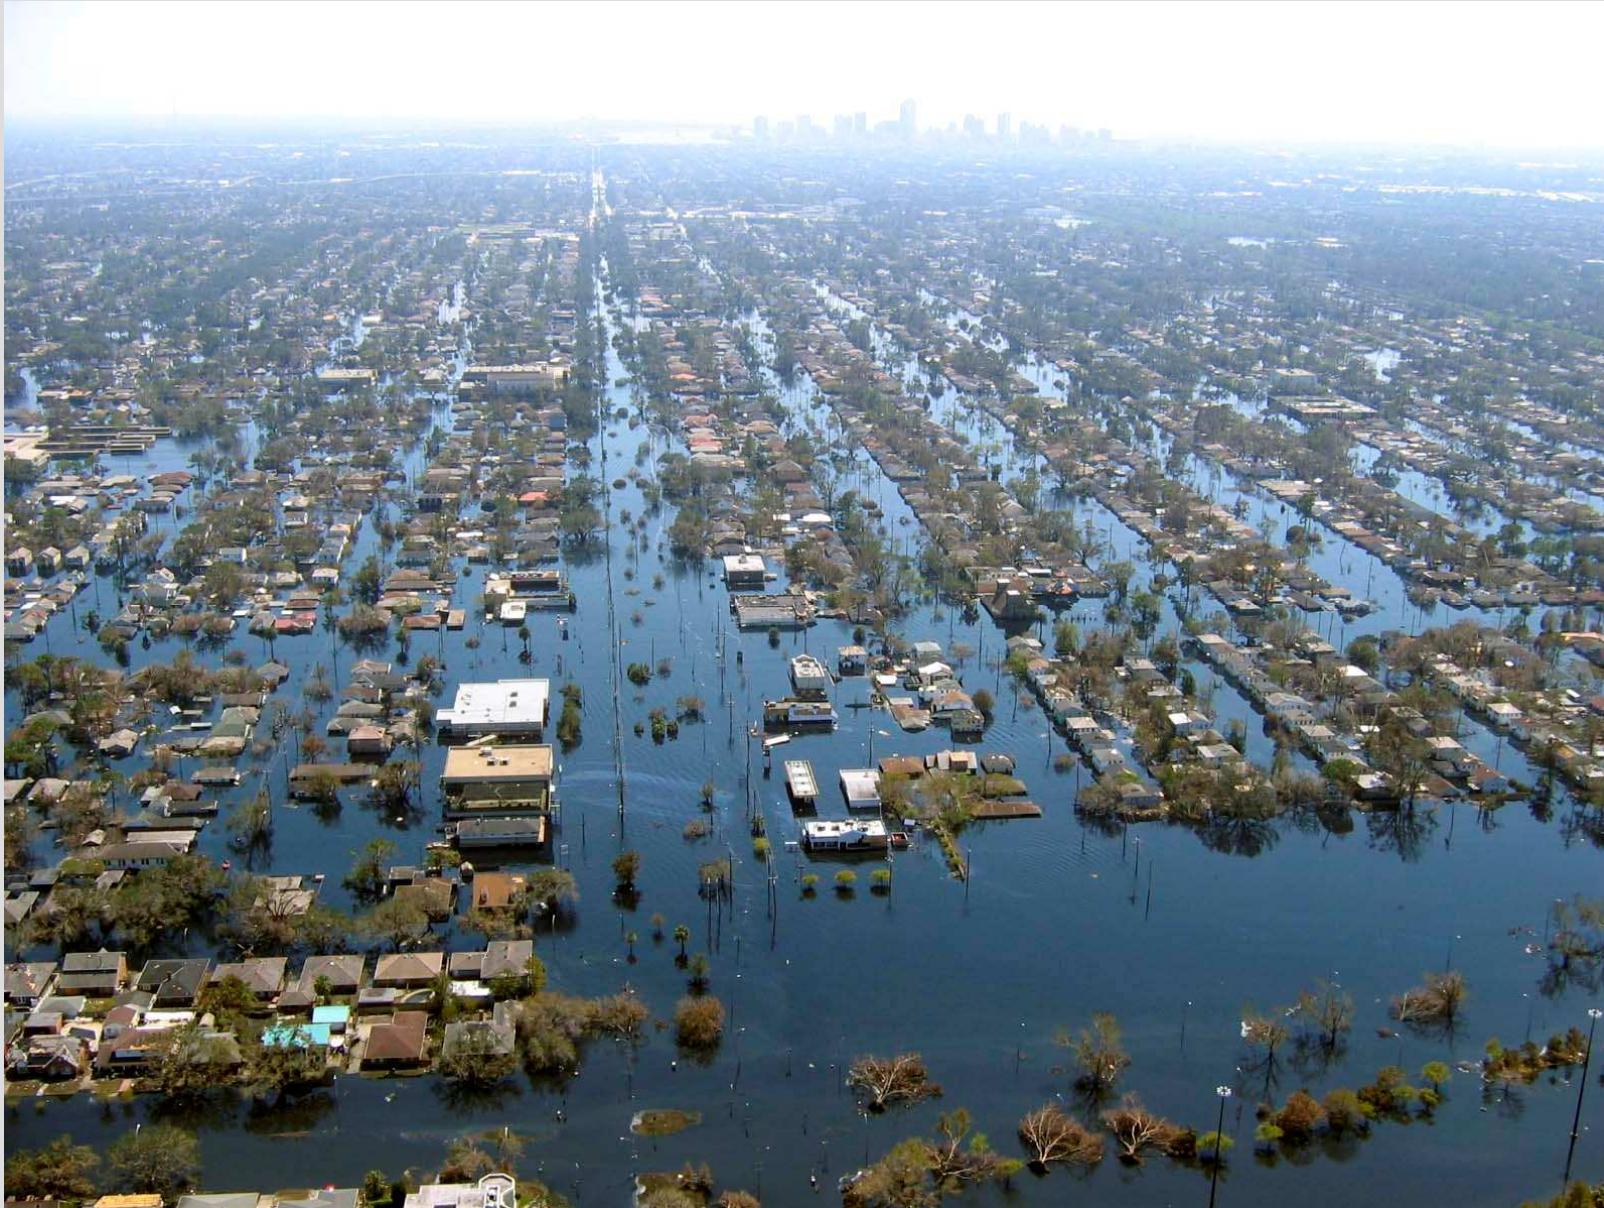
Aerial photograph of New Orleans after Hurricane Katrina
